Australian Antarctic Treaty Inspections January/February 2020

Report of Inspections under Article VII of the Antarctic Treaty and
Article 14 of the Protocol on Environment Protection to the Antarctic
Treaty

Jang Bogo Station (Republic of Korea)

Molodezhnaya Station (Russian Federation)

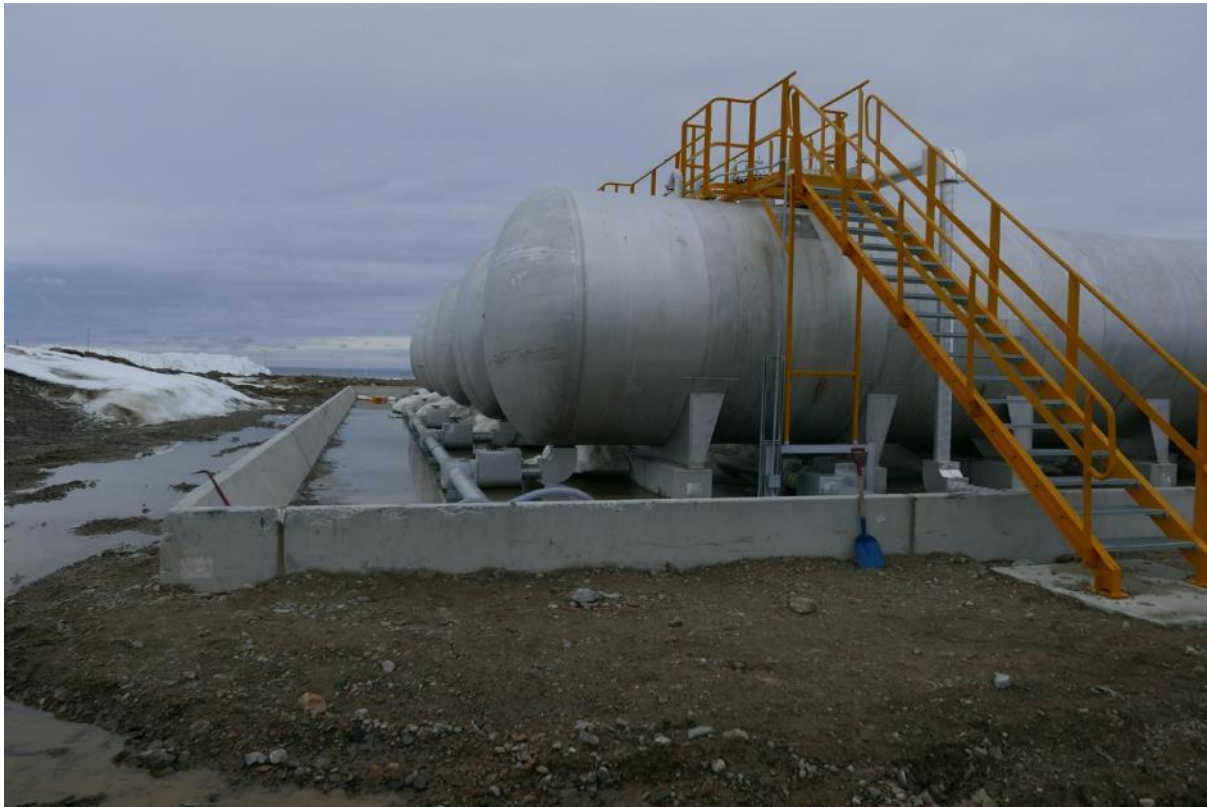
No signs of fuel spills or leaks were observed. The station fuel infrastructure appears to be of a high standard of design and maintenance, and in good condition. Nine large storage tanks were observed, 6 close to the station powerhouse, and 3 close to the pier. Bulk fuel storage was in double skinned tanks with concrete bunding. Station personnel advised that fuel transfer from ship to shore is via barges using Isotainers.

Bunds were well sealed. Fuel lines were well constructed, designed to avoid vehicle damage, and insulated. Station personnel advised that 500 tonnes of fuel is in bulk fuel storage.

Photo: Bulk fuel storage

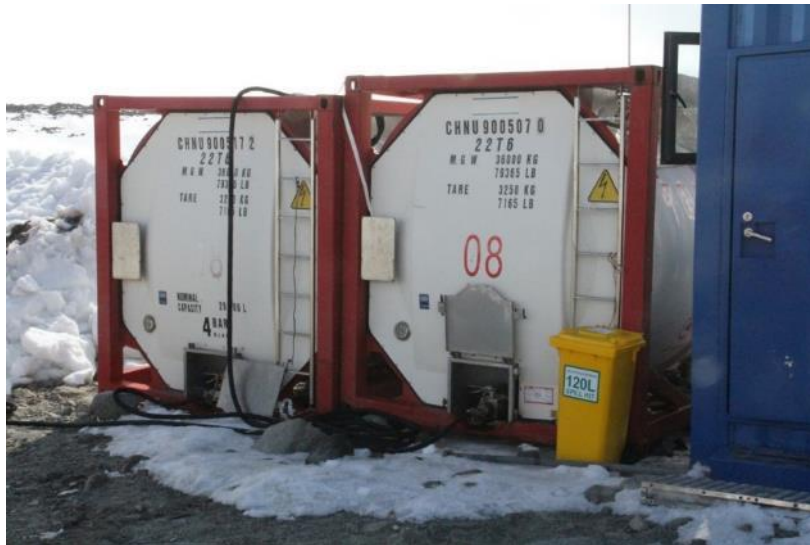
Two 20,000 litre single-skinned isotainer fuel tanks are located close to the generator container. These connect to the generators by a rubber fuel hose run over the ground. A spill kit was located near the fuel tanks. There was no evidence of fuel spillage on-site. The inspection team noted that the current fuel handling arrangements appear to be temporary in nature. Nonetheless, the use of rubber fuel lines in vulnerable locations and single skinned containers poses increased risk of fuel spills. As the facility is further developed, attention to enhanced fuel infrastructure, systems and procedures, including secondary containment would be warranted.

Photo: Fuel tanks

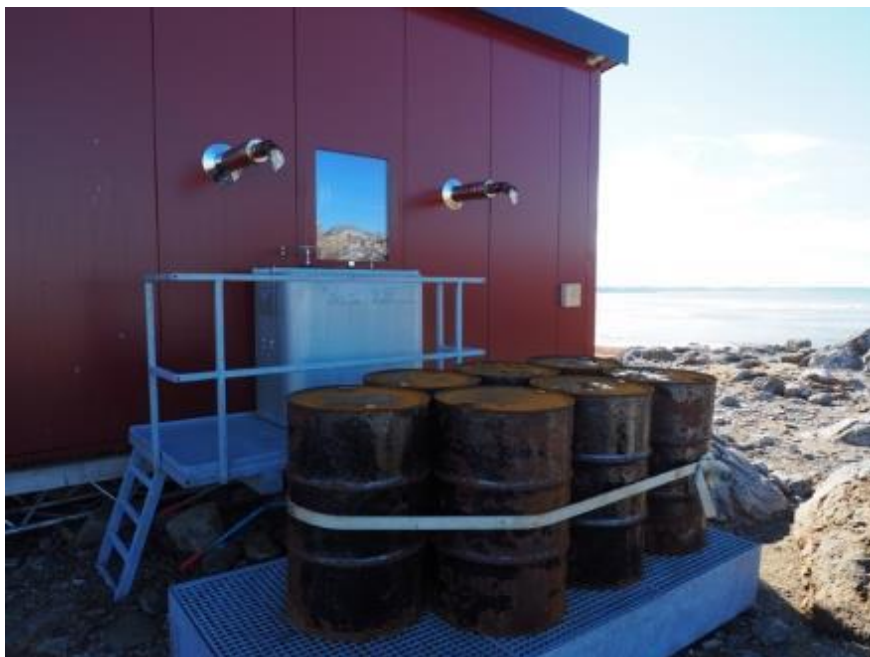
Photo: External fuel tank on power building, and drums on spill containment pallet

A small external tank on the power building adjacent to the generators, likely for generator fuel, was in good condition. Seven 200 litre drums were secured nearby, on a spill containment pallet.

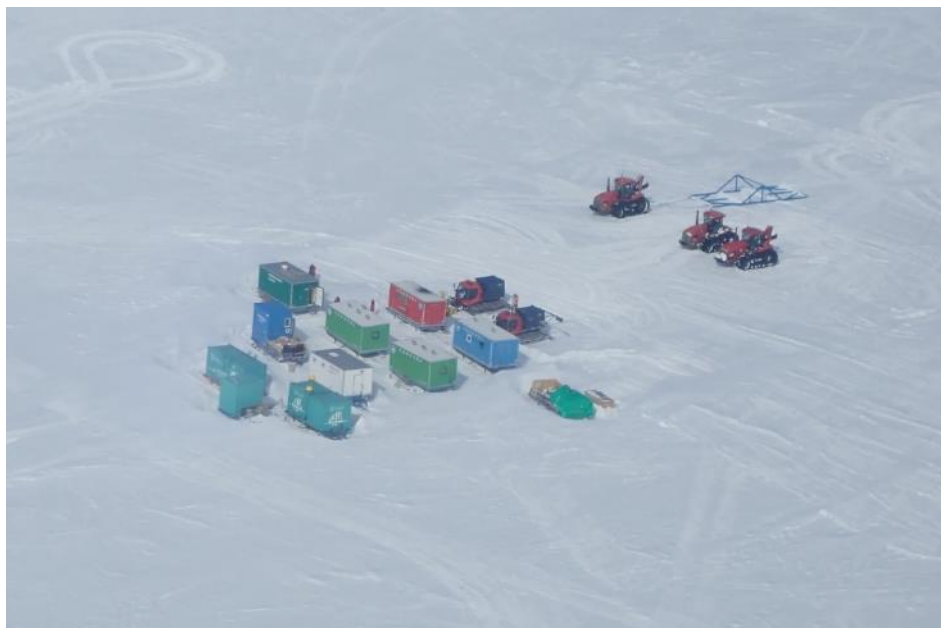
Photo: Mobile site with traverse infrastructure

Management of snow accumulation over time may pose challenges for operations. The inspection team noted relatively high rates of snow accumulation in the station area, with accumulation around the main camp building, and over the undersnow building, and significant snow drifts and 'blizzard tails' accumulating near vehicles and equipment.

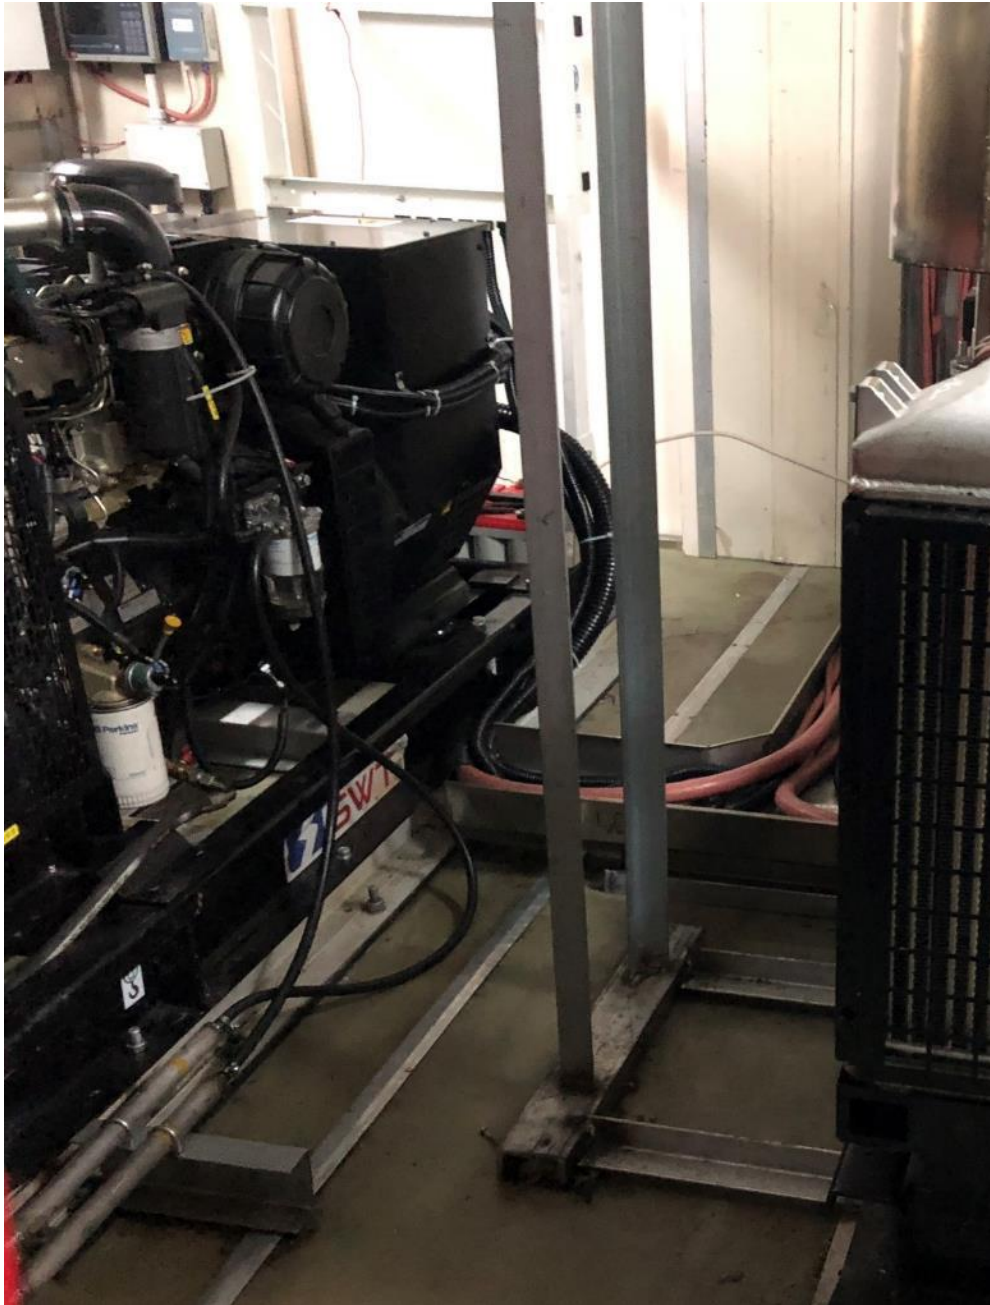
Fuel storage and transfer systems for the generator sets operating in the undersnow building were not evident to the inspection team, as the facility is entirely snow covered. A feeder tank and generator fuel lines were observed inside the undersnow building. The inspection team noted that fuel lines from the feeder tank to the generators appeared to be of galvanised pipe, with welded joints and fixtures, rather than purpose-designed fuel lines and fittings. In the view of the inspection team this may increase the risk of fuel spills and fire hazards.

Photo: Generator sets and fuel lines

The inspection team also notes that monitoring and maintenance of fuel infrastructure will be challenging given the environmental conditions and challenges with accessing external (but snow covered) pipework and fittings. The inspection team did not observe spill kits or secondary containment for the feeder tank, pipework and fittings. Significant challenges may be encountered in fuel recovery should there be a leak or spill, and loss to the ice and snow environment underlying the undersnow facility would be likely in the event of an incident.

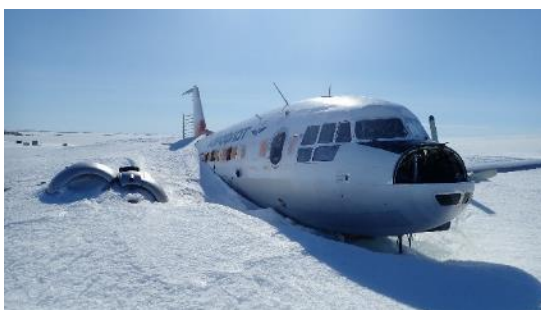
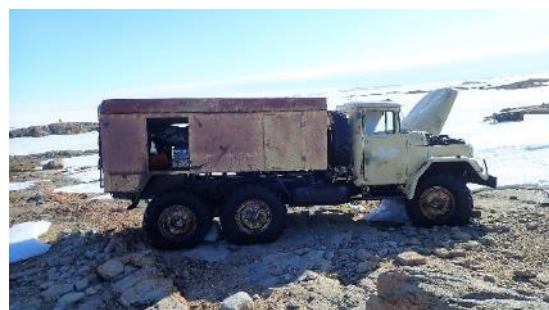
Photo: Disused aircraft and vehicle

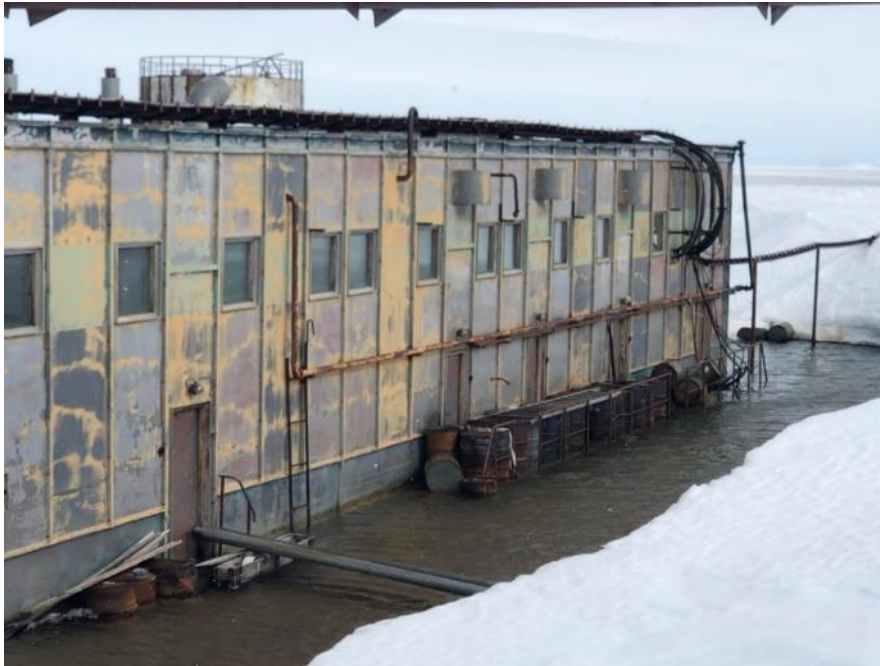
Photo: Melt pond around building with inundated drums

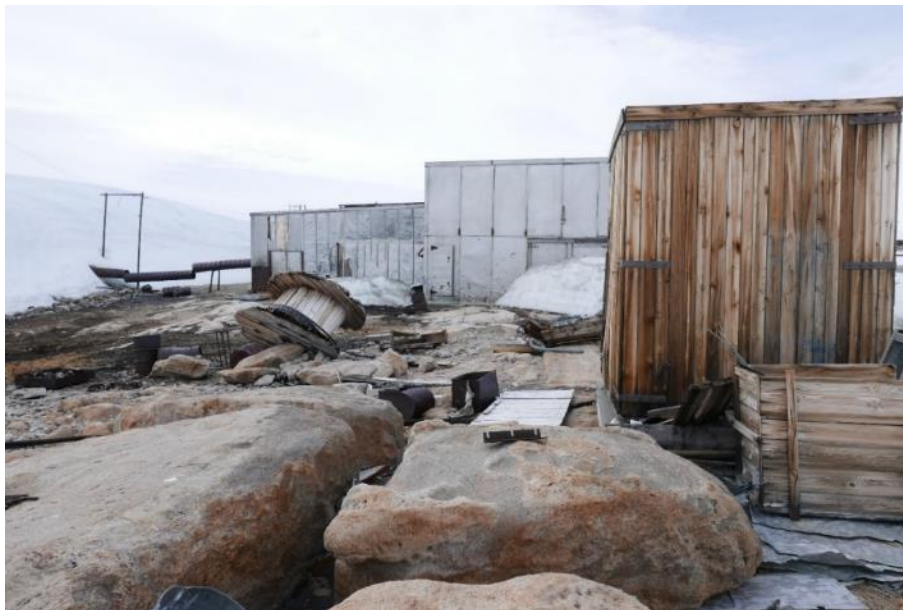
Photo: Buildings with damaged materials

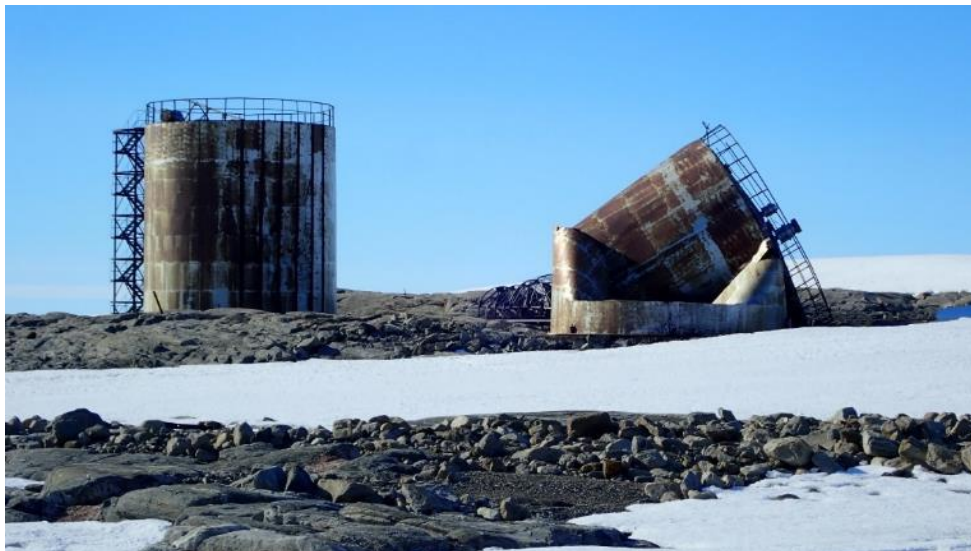
Photo: Damaged large fuel storage

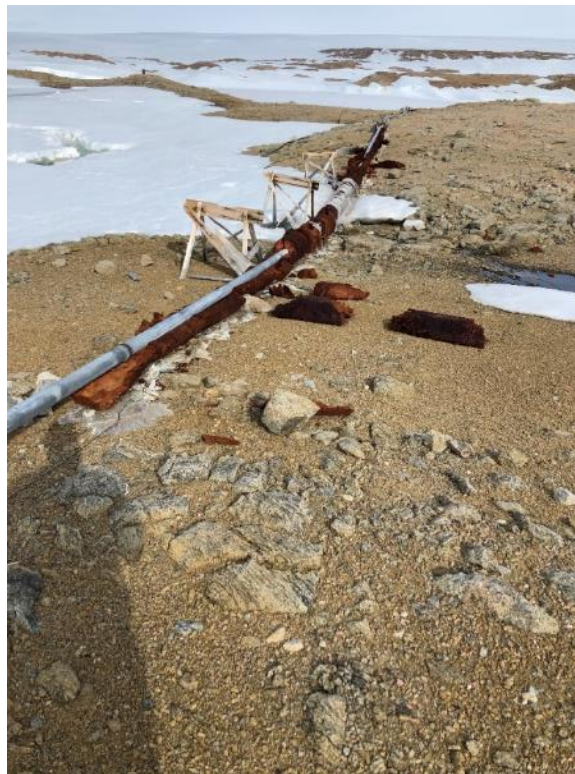
Photo: Water pipeline with deteriorated and liberated insulation

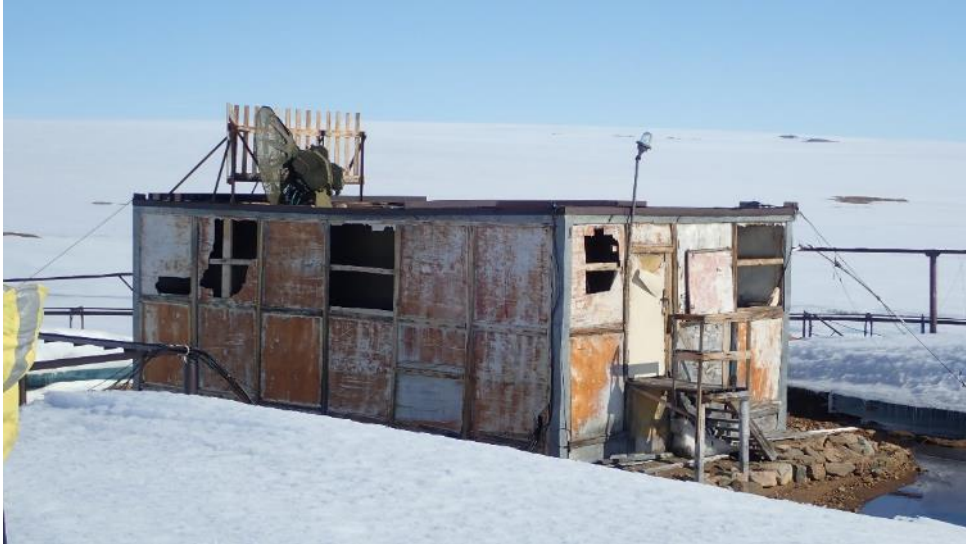
Photo: Deteriorating building

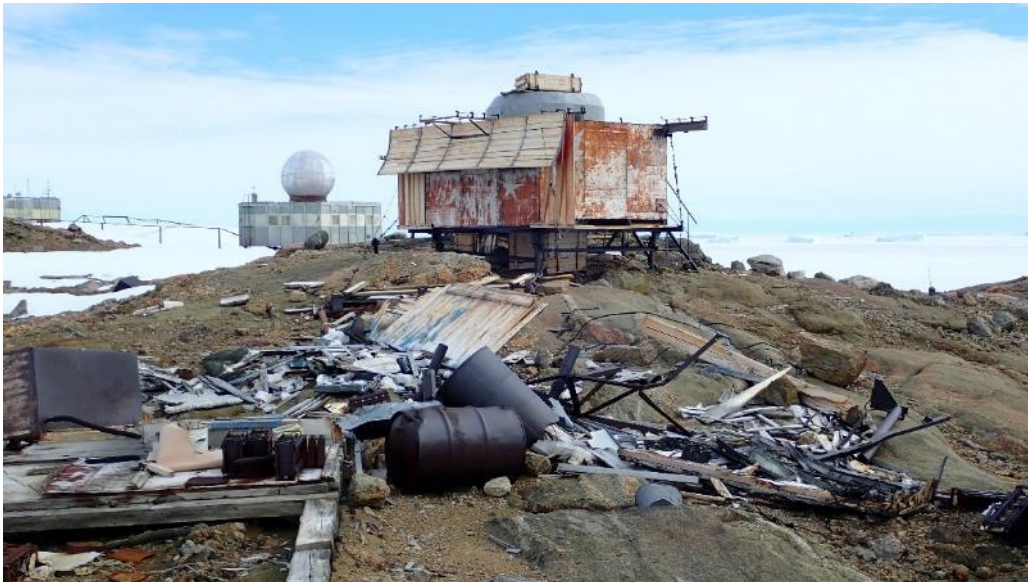
Photo: Deteriorating building and discarded waste

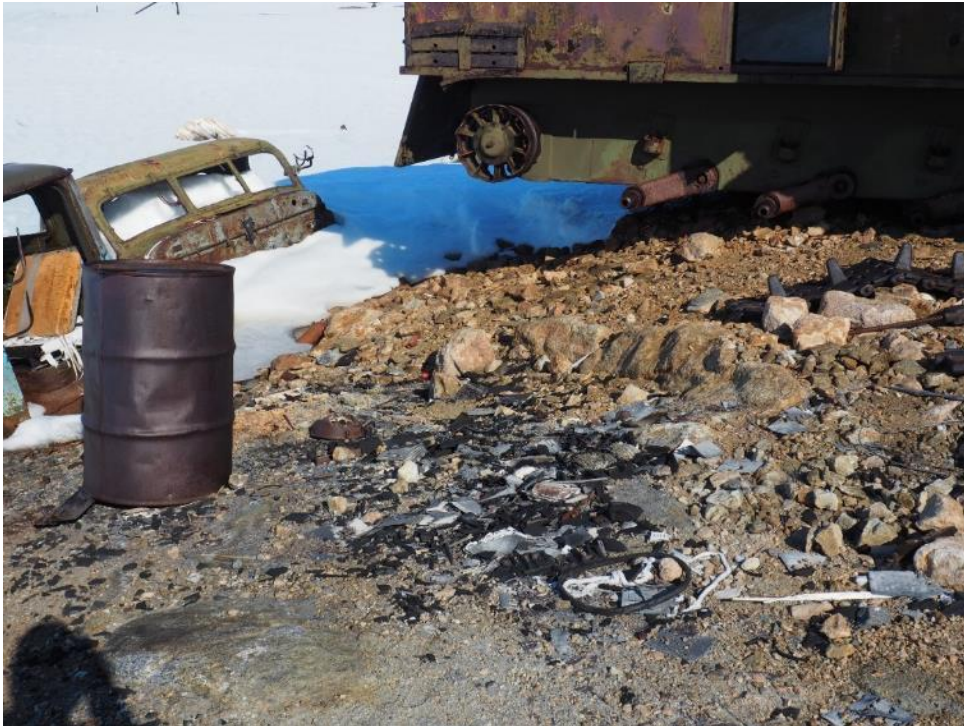
Photo: Remnants of open burning of waste
