The conservation of Mawson's Huts

A JOINT VENTURE INVOLVING THE FEDERAL GOVERNMENT and the AAP Mawson's Huts Foundation completed the third phase of a conservation works program in January 2001 to save the historic huts used by the Australasian Antarctic Expedition (AAE) 1911–14 led by Australia's most acclaimed Antarctic scientist and hero, Sir Douglas Mawson.

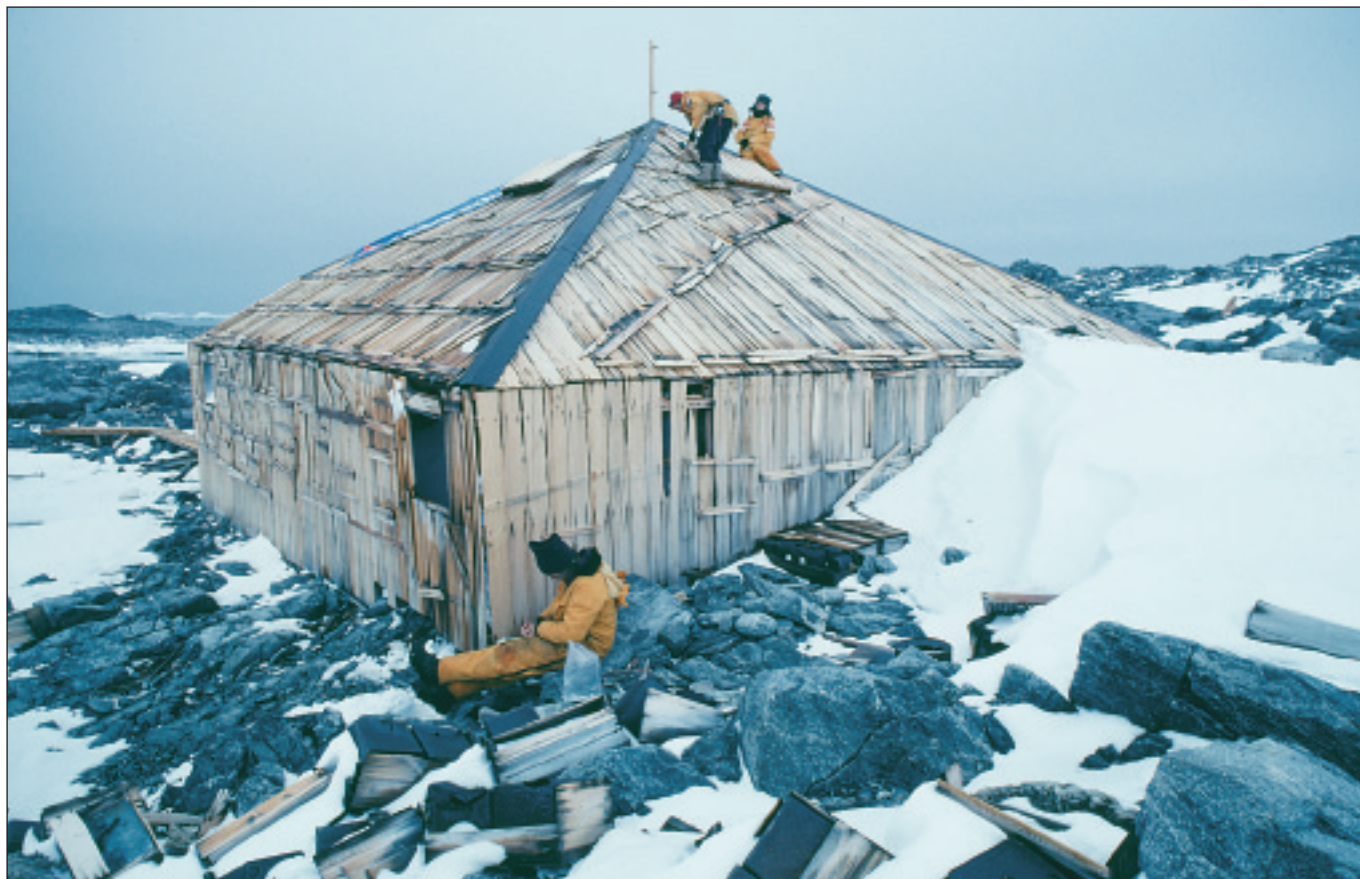
Carpenter and heritage specialist examine main hut roof, while materials conservator (foreground) measures moisture content of hut cladding.

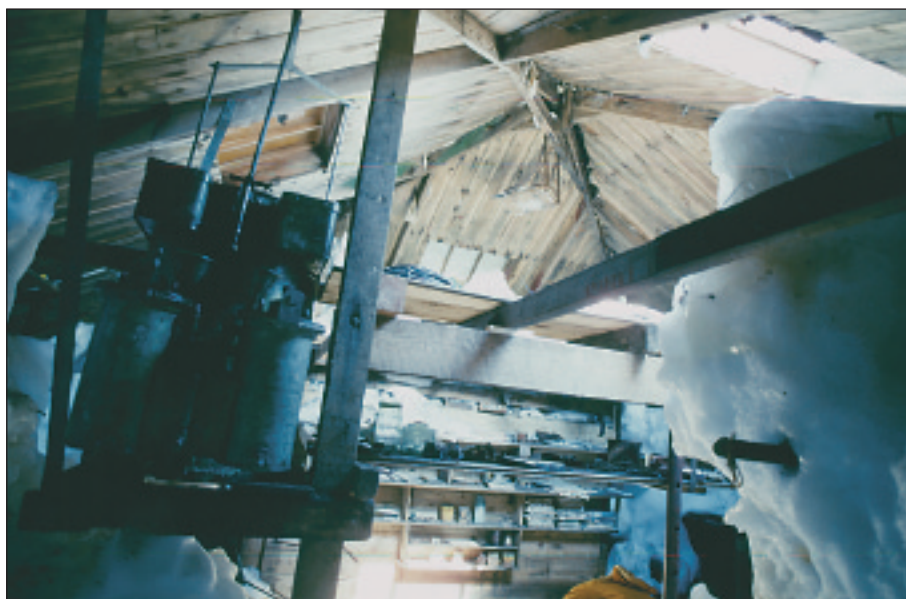
Interior of the main hut showing ice accumulation surrounding bunks and storage platform. In the left foreground is the acetylene plant used for lighting. ROB EASTHER

The most controversial issue surrounding the conservation of the huts has been whether or not the large amount of snow and ice inside the main living hut (about 60% of the space) and adjoining workshop should be removed. Concern for the artefacts inside (if the relative humidity and temperature are changed by the removal of snow and ice) and potential risks to the structural stability of the huts are important considerations that have greatly restricted the options for returning the huts to their former condition.

But the environmental data (collected by electronic monitoring equipment over the past three years), the work of the last two expeditions and observations by heritage building specialists Godden Mackay Logan, and the carpenters and architects employed by the Foundation, suggest that the internal space should be excavated to expose the many artefacts of the AAE thought to be entombed in the ice and not seen since 1931 when Mawson last visited. Replacing the wooden battens that Mawson's men tacked on the joints of the tongue and groove Baltic Pine timber on the roof (which have mostly blown away) would significantly reduce the ingress of snow and ice into the space. Such action would reveal the full extent of the winter quarters, and allow visitors to appreciate the full spirit of this extraordinary place.
