MAWSON'S HUTS HISTORIC SITE

MANAGEMENT PLAN 2013-2018

Mawson's Huts Historic Site Management Plan 2013-2018

Australian Antarctic Division

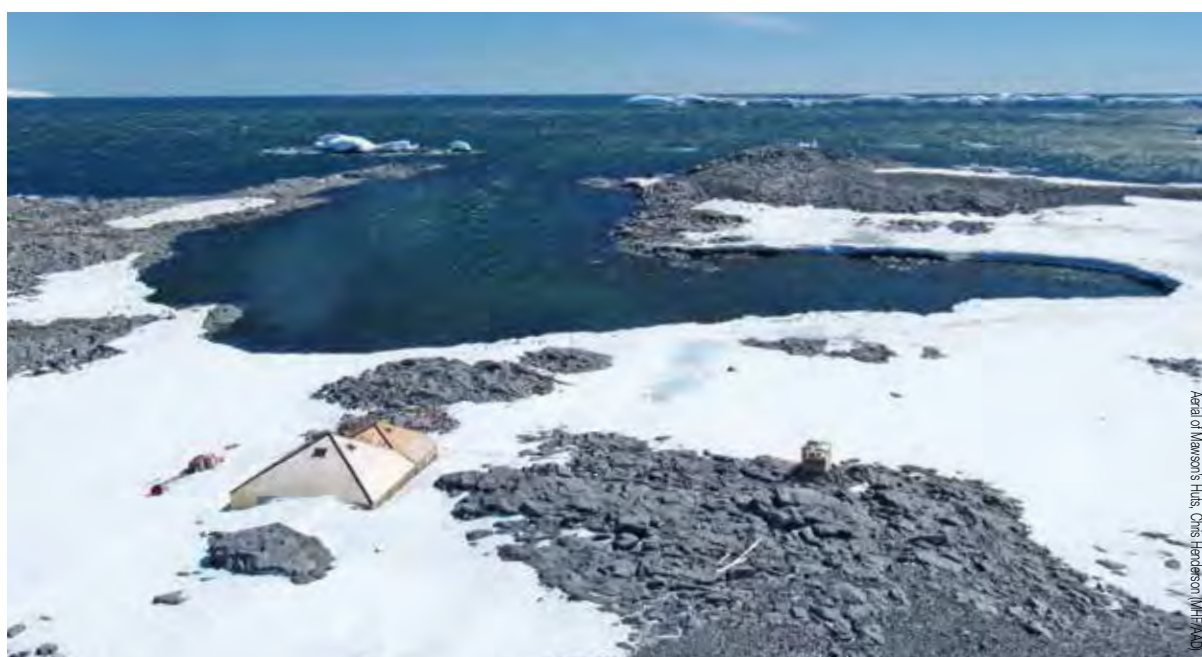
MAWSON'S HUTS, CAPE DENISON VISUAL PROTECTION ZONE

The ASMA management plan establishes a Visual Protection Zone containing the historic structures and designed to exclude new structures to preserve the values of the site.

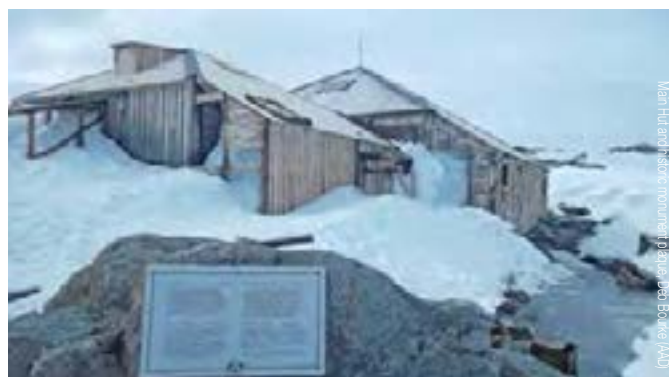
The Main Hut consists of two prefabricated Oregon-framed timber huts with foundations set in 50 t of loose rocks. Structural timbers are bolted together with tongue-and-groove Baltic pine used for internal and external cladding. A 1.5 m wide verandah surrounds the structure on three sides.

The living section, prefabricated by George Hudson & Son (Sydney), is 7.3 x 7.3 m with a pyramid shaped roof supported in the centre by four 100 mm by 100 mm posts. There are four skylights, all with glass and timber covers which can be opened. Bunks are arranged in two tiers around the walls, leaving a central living space for the stove and dining table. There are two separate rooms: Mawson's cubicle and Hurley's small dark room.

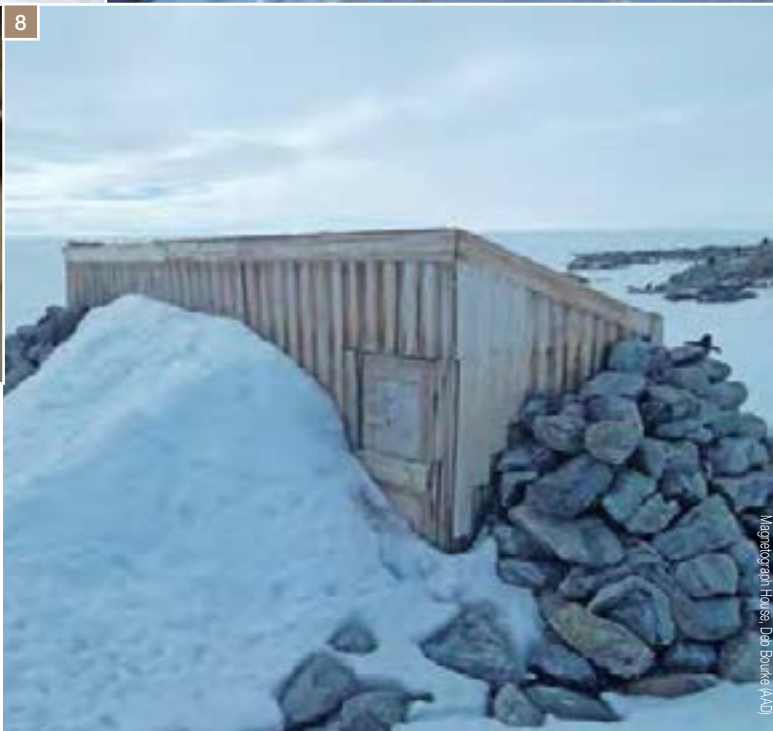
Magnetograph House, Dea Bourke (A.U.)

The Magnetograph House is an Oregon frame timber hut, prefabricated by Risby Brothers (Hobart) and erected in March 1912. Tongue-and-groove Baltic pine boards are used for internal and external cladding, and the walls are reinforced by approximately 30 t of rock. Fastidious steps were taken to make the building impervious to wind. Sheets of tarred builders paper were installed under each timber lining and a final continuous tarred paper covering was placed over the inside wall. The whole of the framework was secured by means of copper spikes and bolts. A shortage of small copper nails necessitated the use of some iron nails to fasten the lining but not within 6' of the instruments. The building was insulated with some twenty sheep skins on the roof and windward side. The plan is rectangular – 5.5 x 2 m. The shallow-pitched skillion roof has a copper ventilator. There is an inner and outer porch with three door sets. The external door is a double 'stable' ship's door taken from the *Clyde* shipwrecked at Macquarie Island. The internal door is inscribed with a description on how to enter and exit the building.

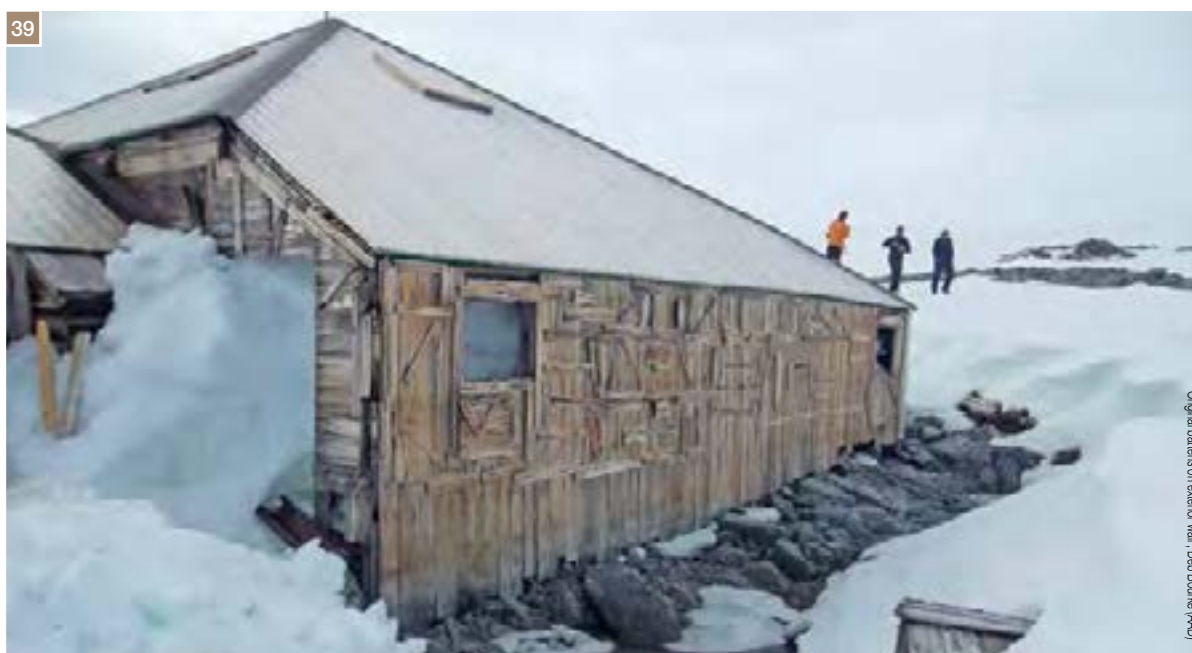
The original roof claddings of the Main Hut and Magnetograph House are elements of high integrity in poor condition – the eroded original roof boards are now encapsulated beneath new timber over-cladding. Abrasion of the roof cladding by wind-driven ice, coupled with the large spans between supports for the cladding, meant that the roofs on the workshop of the Main Hut and the Magnetograph Hut were close to failure when inspected in 1997. Both roofs have since been over-clad. This intervention secured the structural integrity of the buildings at the cost of some of the value embodied by a feeling of time elapsed and exposure to the elements. [39]

Over-cladding of the workshop roof was completed in 1998 on the basis that structural failure was likely due to the abrasion of the original timber boards, from a thickness of 16 mm to less than 10 mm. This work preserved the structure, provided additional diaphragm bracing and reduced snow ingress. It also produced some unintended consequences. The first was visual. The original work plan was changed and the new boards were placed over the top of the old boards. This change in methodology meant that the Intergrain™ coating on the new boards lasted longer than expected and impacted on the appearance of the workshop roof until the coating was sanded off in 2011. The other consequence was the loss of all but three of the original battens that were refixed on top of the over-cladding, due to the failure of nails and silicon.

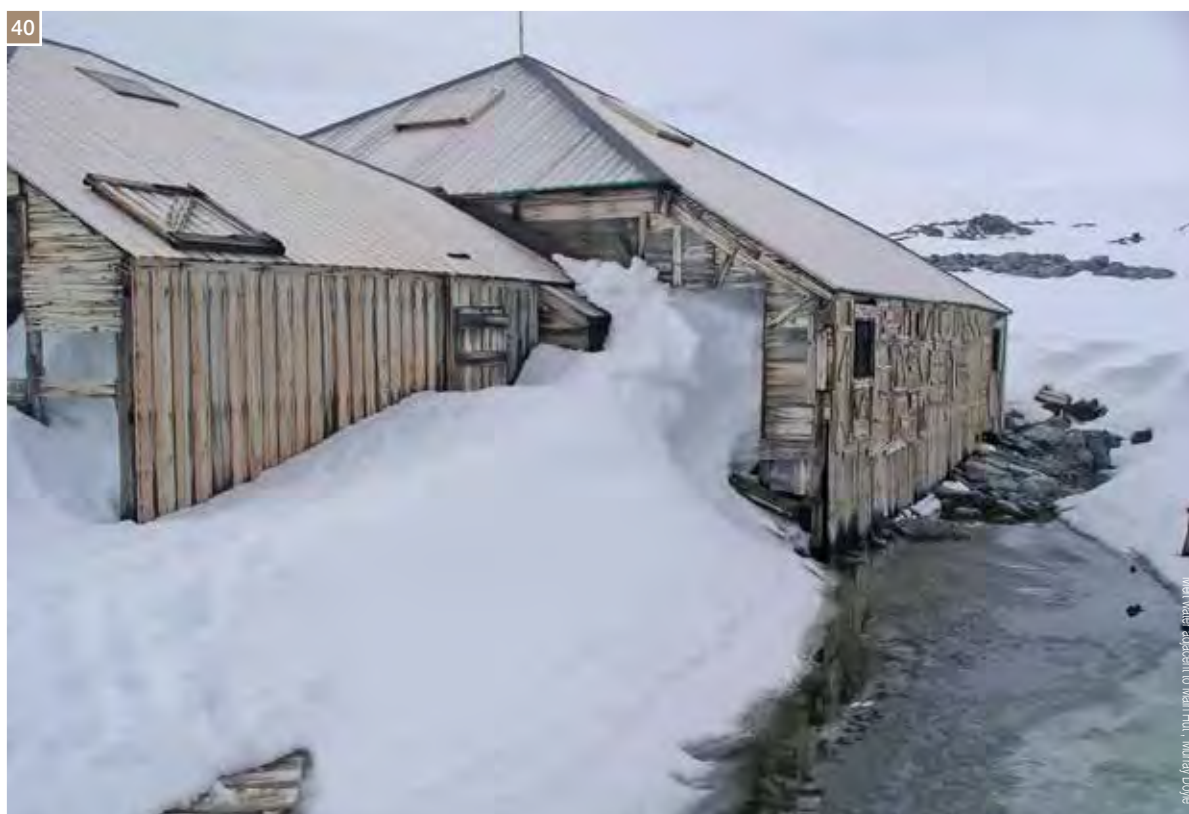
Over-cladding of the living section of the Main Hut roof which had thicker (25 mm) boards but was also deteriorating (the edges and corners had abraded at the rate of 1 mm every ten years since construction), was completed in December 2006, in a manner which entirely encompasses the boards. Over-cladding was considered the only remaining option to secure the interior from future snow/ice ingress and preserve the significant fabric, and was noted to be a temporary and reversible measure. This work was done to reduce snow and melt water ingress, protect and retain the remaining cover battens, and maintain the structural integrity of the roof plane. Learning from the workshop experience, the roof was re-clad in a different manner – using uncoated timber and a vapour permeable fabric membrane between the original roof and the over-cladding. Weathering should lessen its visual impact. [40]

With the over-cladding in place, the original roof is expected to be in good condition structurally, although snow may still penetrate at some of the junctions between the roof and the walls in both the workshop and the living quarters.

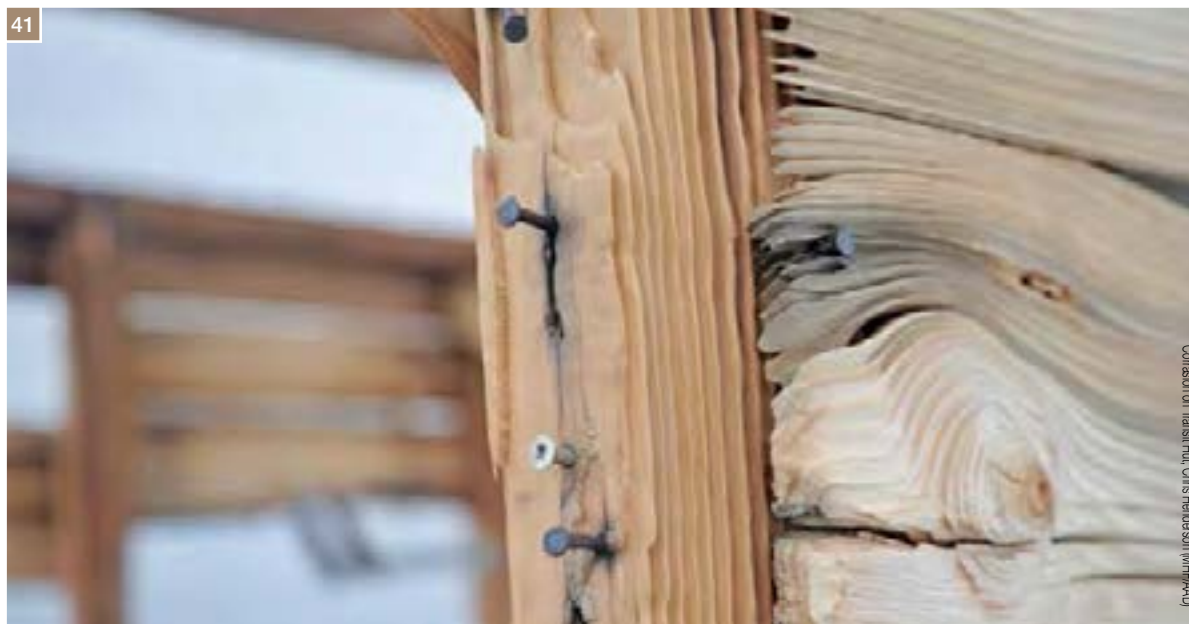
Cape Denison is perhaps the windiest place on earth at sea level, with an average daily maximum of 71 kph. Gusts and frequent blizzards exceed 100 kph. The greatest single long-term threat to the structures is abrasion from wind-driven snow and ice ('corrasion'), which wears down the surface of softer fabrics such as timber, as well as 'plucking of weathered fibres' on the leeward sides of structures. Abrasion resistance in timber is generally a function of density, but weathering of the surface is probably more significant in determining the loss rate at leeward locations. This is probably the case for the memorial cross where it has been suggested that plucking has removed more timber than corrasion. Further analysis of monitoring data is required to better understand the processes of wind damage in order to develop effective treatments or mitigation measures. [41]

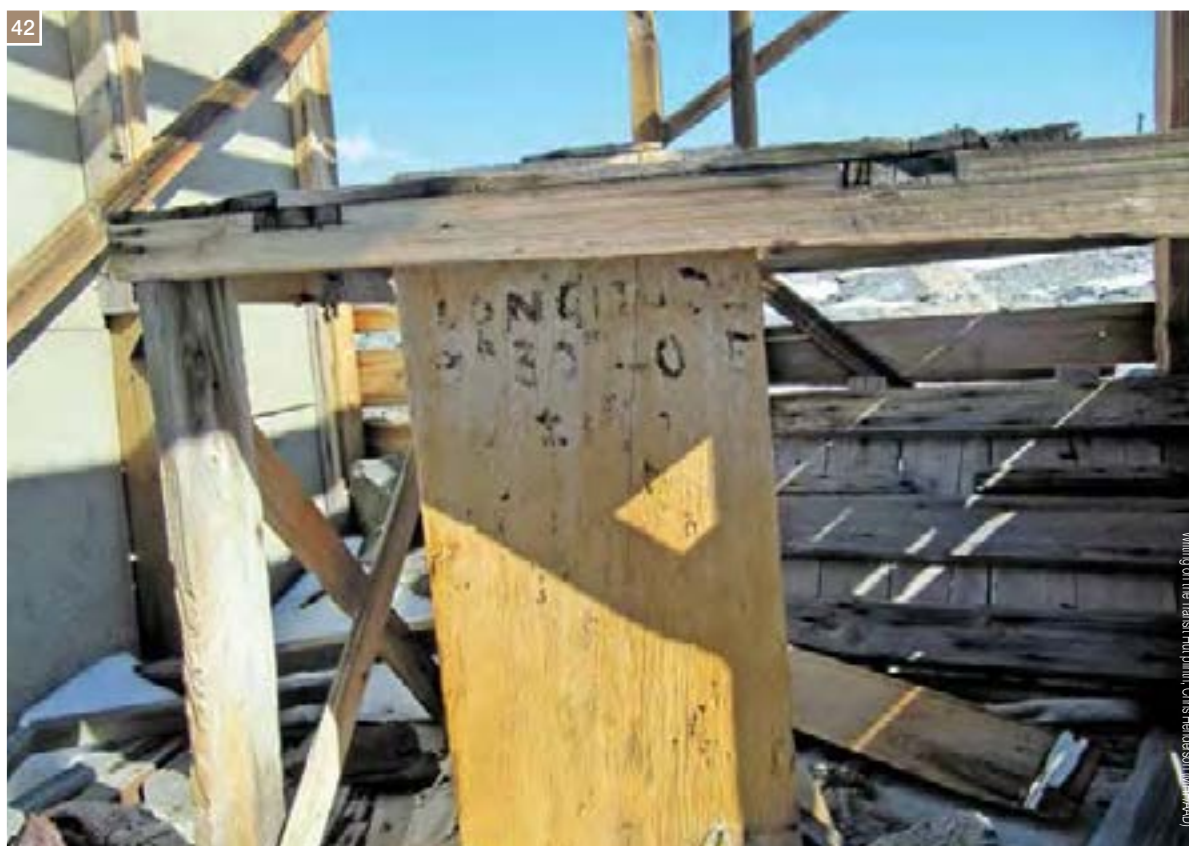
Timbers with a density greater than 800 kg/m³ have good abrasion resistance. Baltic pine, used as cladding on Mawson's Huts, with a density of 550 kg/m³, is relatively susceptible to abrasion. Since its construction, the roof-cladding boards on the edges and corners of the two sections of the Main Hut have weathered at a rate of up to 1 mm every ten years. Because the workshop roof was constructed of thinner boards (16 mm compared to the 25 mm on the living section) it reached a dangerously deteriorated state earlier than the living section roof, and was the first to be over-clad with new timber (Godden Mackay Logan 2001). A similar situation was occurring to the Transit Hut where corrasion had worn down the exposed timber to the point of possible collapse. In 2010 a portal frame was fitted to the inside of the structure to reinforce the structure while still preserving the heritage values of the hut. While the structure itself is now strengthened, the cladding timbers are still subjected to the effects of wind.

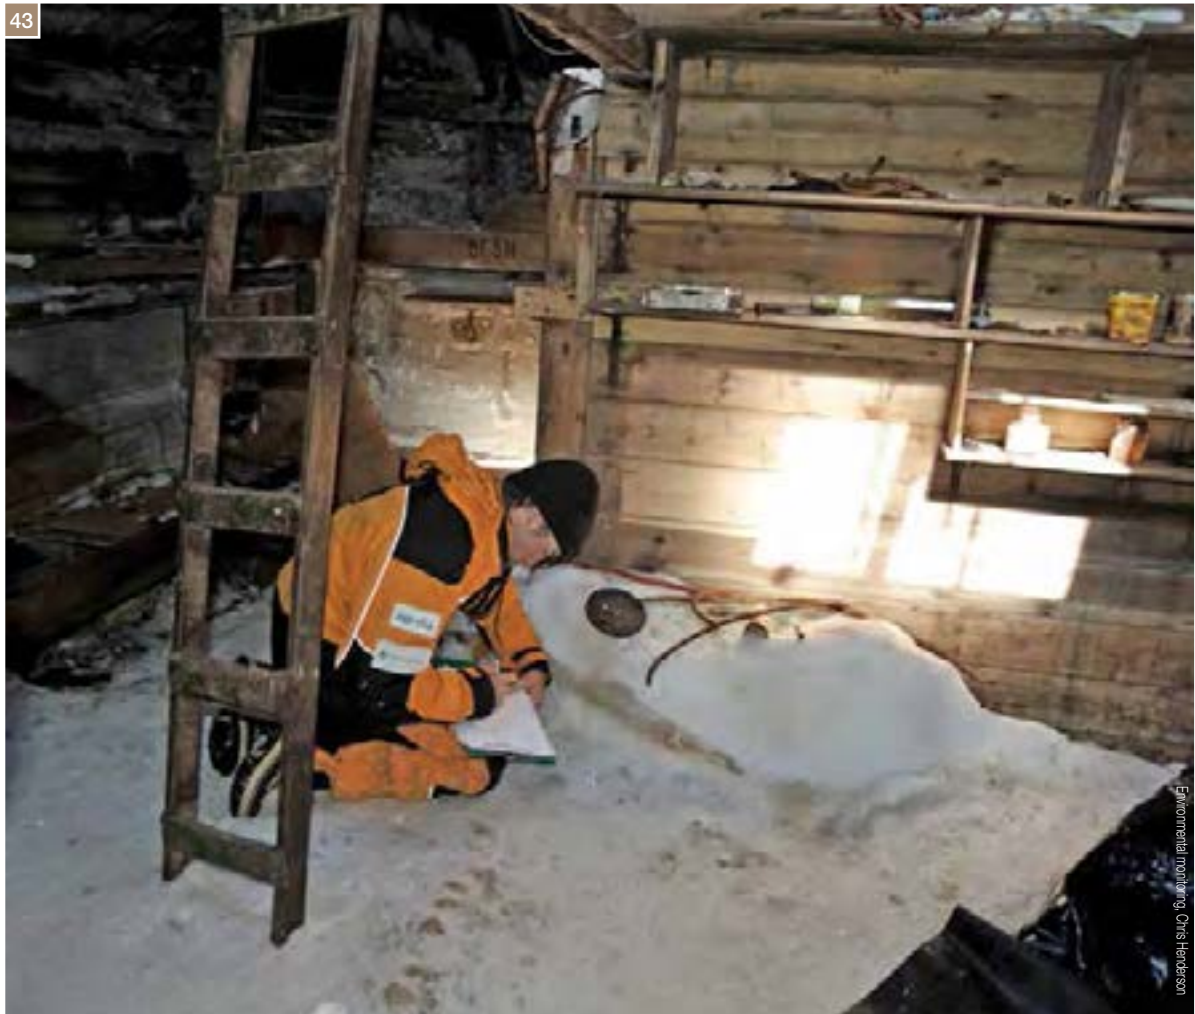
Data loggers have been used to monitor the external Cape Denison environment and micro-environments inside Mawson's Huts since the summer of 1998/99. Temperature and relative humidity data accumulated over this time, supplemented by corrosion studies using bimetallic CLIMAT bolts and copper-steel coupons, has been used to guide conservation decisions regarding ice removal from the interior of the Main Hut and to provide information on the effects of the high humidity environment on the structures and the corrosion of iron fastenings and fittings. These data have also been used to monitor the impacts of snow and ice removal on internal microenvironments of the Main Hut. While this monitoring will continue, additional monitoring of moisture within walls and ceiling will also be undertaken. This information will assist in understanding the climatic impact of the over-cladding of the roof and the potential need for better ventilation. [43]

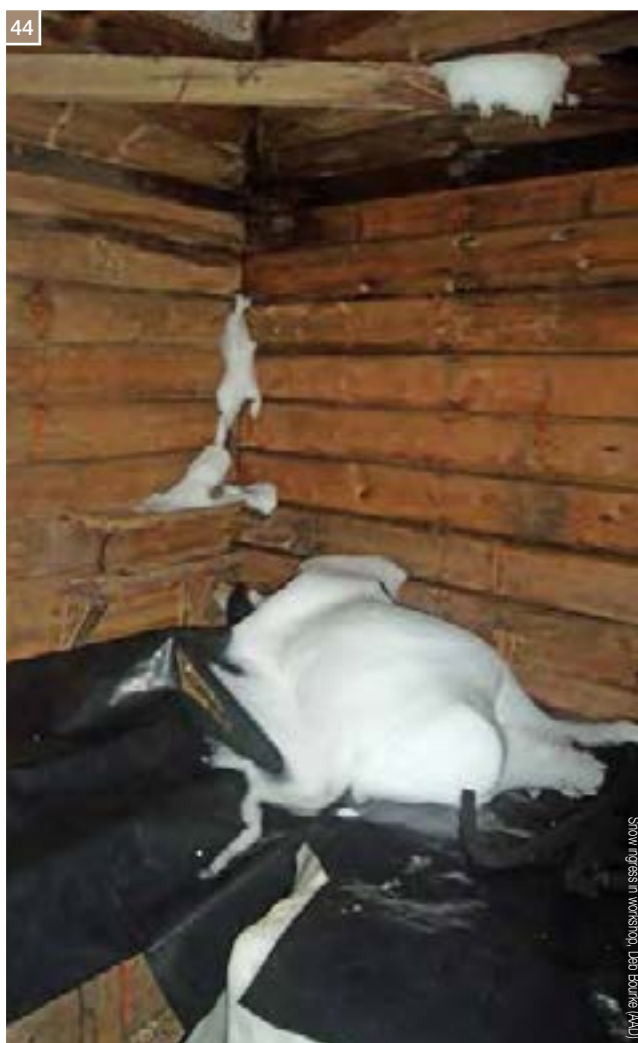
Snow ingress in workshop, Deb Bourke (A4D)

The site is regularly affected by diurnal and seasonal freeze and thaw cycles. In winter, the Main Hut is typically buried to the top of the walls by drift snow. During summer seasonal melt cycles, the western and eastern walls often collect melt pools that abut the external timbers, with visible tide marks on the exterior cladding. This may increase the risk of melting of ice in the internal verandah and large melts may cause flooding under and possibly even in the Main Hut. The Oregon timber frame of the Main Hut, where it has been subjected to occasional exposure to water in these pools, shows no signs of damage to date but the potential impact of this activity needs to be monitored over time to identify any changes. In summer, when much of the external snow ablates and melts, melt water pools and streams sometimes form around the Main Hut. During these times, access into the hut may be more difficult for tourists and conservation parties. Melt water is not a straightforward issue since it is difficult to remove, and exposure to air may increase bio-deterioration and corrosion risks more than inundation in water. [45][46]

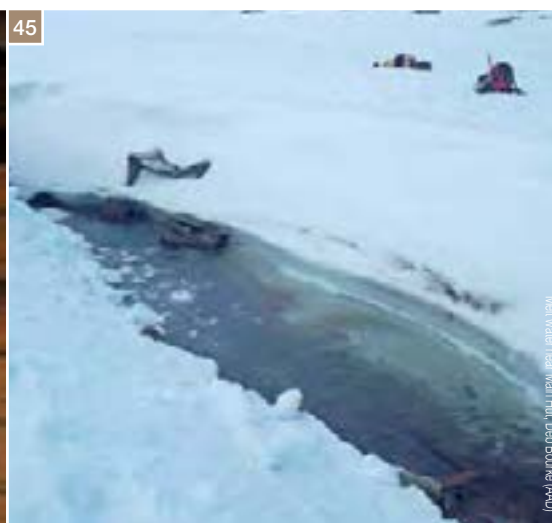
Melt water adjacent to Main Hut, Murray Doyle
