Australian Antarctic Treaty Inspections January/February 2020

Report of Inspections under Article VII of the Antarctic Treaty and
Article 14 of the Protocol on Environment Protection to the Antarctic
Treaty

Jang Bogo Station (Republic of Korea)

Molodezhnaya Station (Russian Federation)

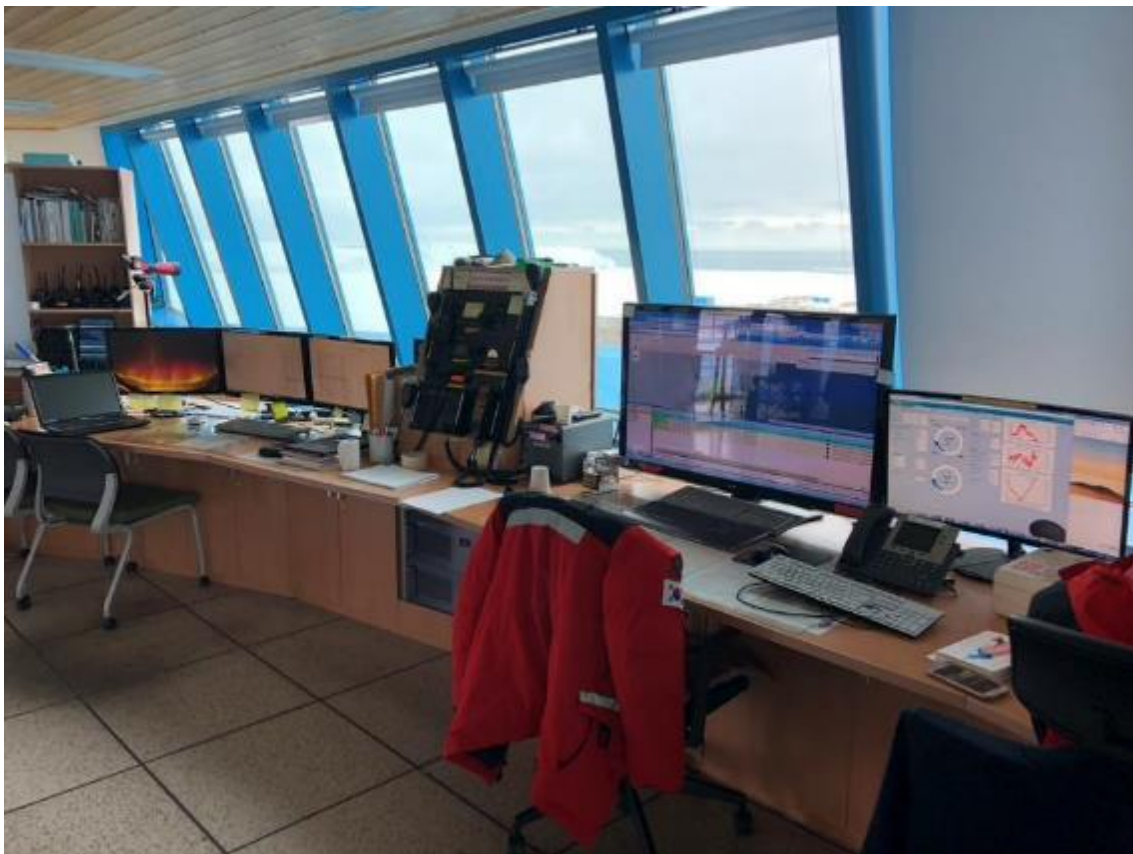
Photo: Integrated operations room

Systems monitoring through the operations room includes fuel tank levels, power generation, and water systems. A closed circuit television system with 47 cameras assists with fire monitoring, safety and operations control.

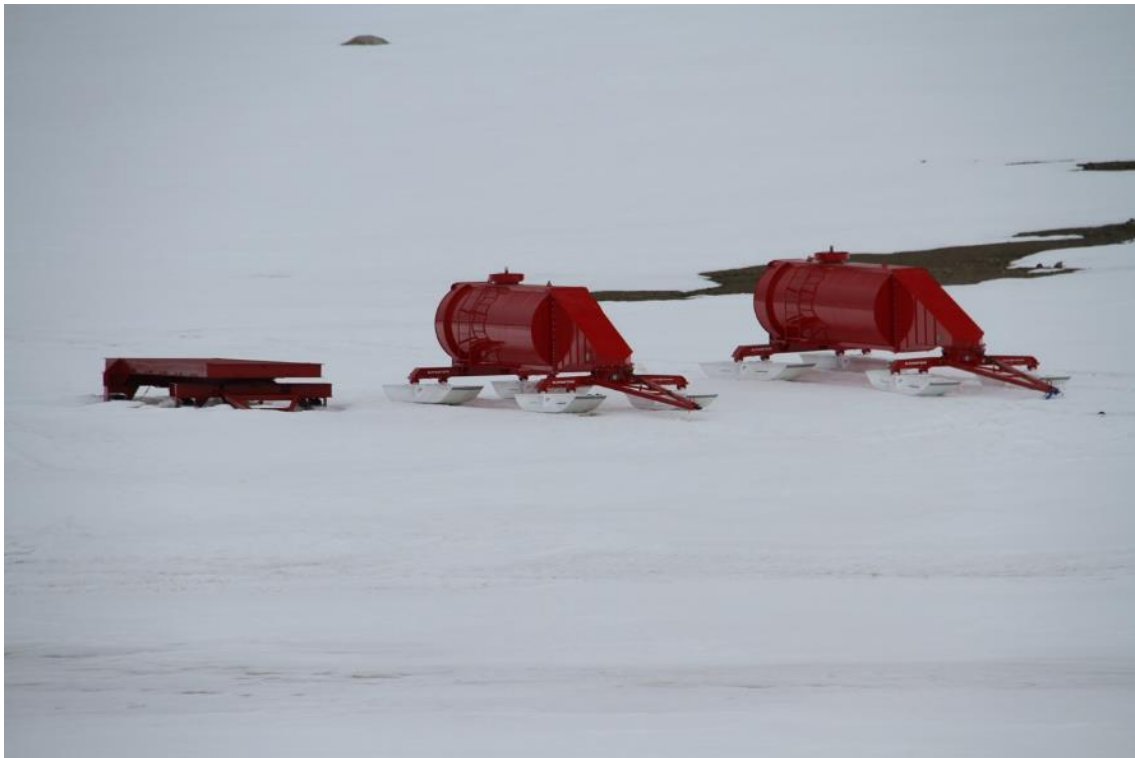
Photo: Traverse sleds

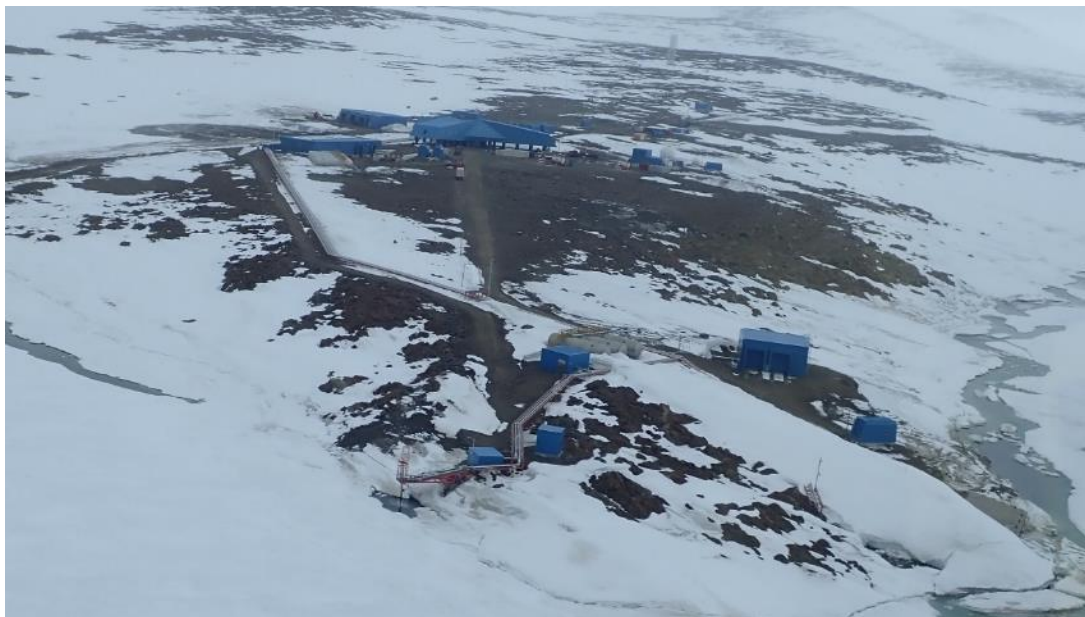
Other buildings, including the powerhouse, warehouses and garages, emergency power and living buildings, and a meteorological building, are arranged in a radial pattern around the main building. Other infrastructure includes a dock close to the station with a nearby complex of buildings, fuel storages, wind power generators, scientific aerial installation and a walk-up research/observation tower. Site services racks between buildings were inspected, and were well designed and maintained, in good condition, and protected from inadvertent vehicle damage.

Photo: Jang Bogo station complex

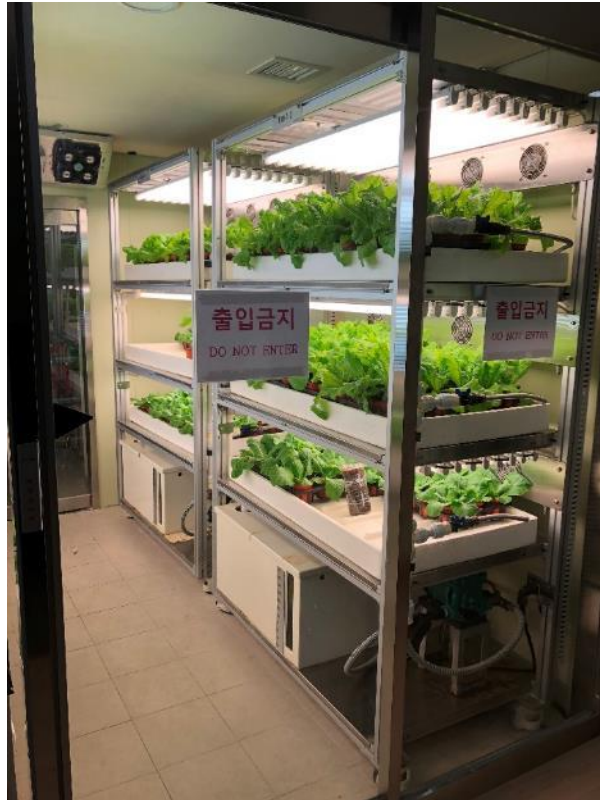
The station supplements stored food with an internal greenhouse facility in the primary building, which can provide up to 5kg of vegetables per week. This innovative feature provides a backdrop of greenery and light with a pleasing ambience (behind glass in a controlled environment) in the main living areas. The team was briefed on the management access control arrangements for the facility. No issues with non-native species have been encountered.

Photo: Greenhouse in main building

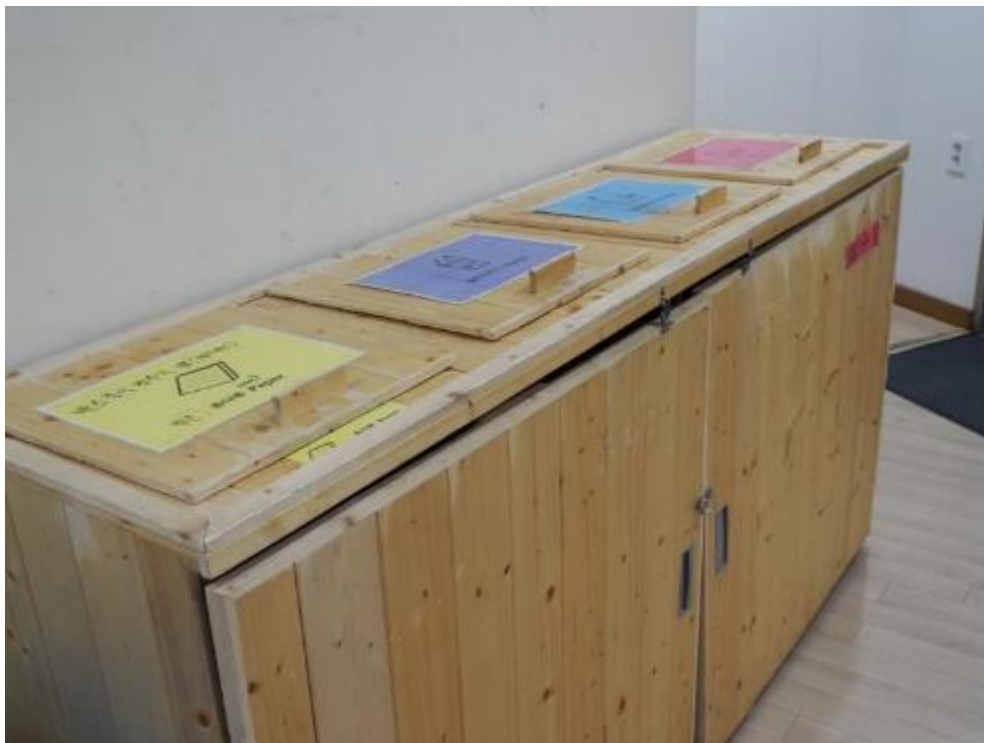
Waste collection and separation systems were observed in all relevant areas of the station, and waste recycling stations were in use in public areas.

Photo: Recycling station

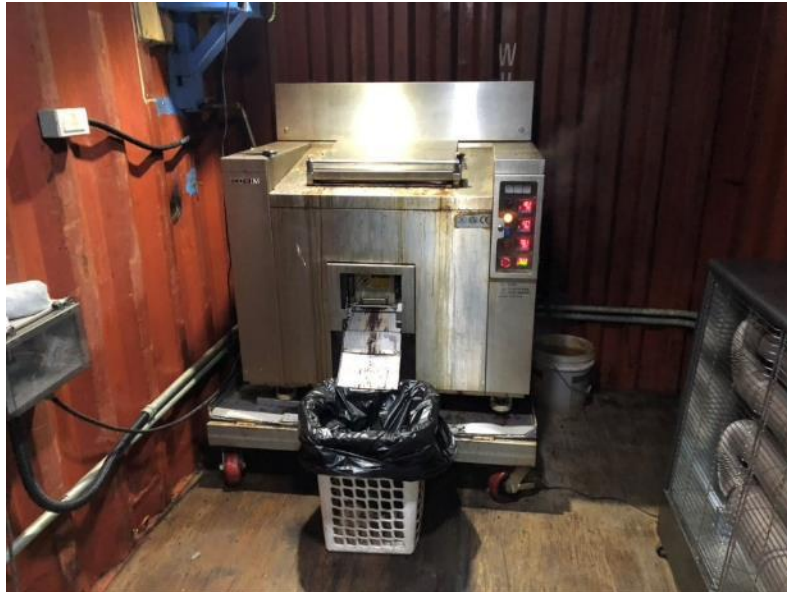
are heated for 19 hours at 190°C, to remove moisture and minimise the volume of solids for removal from Antarctica. The system appeared to be operating effectively, and solid residues were observed to be ash-like particles. A waste compactor unit for baling other wastes was also in use. No outside/uncovered storage of waste was observed.

Photo: Food waste dehydrator

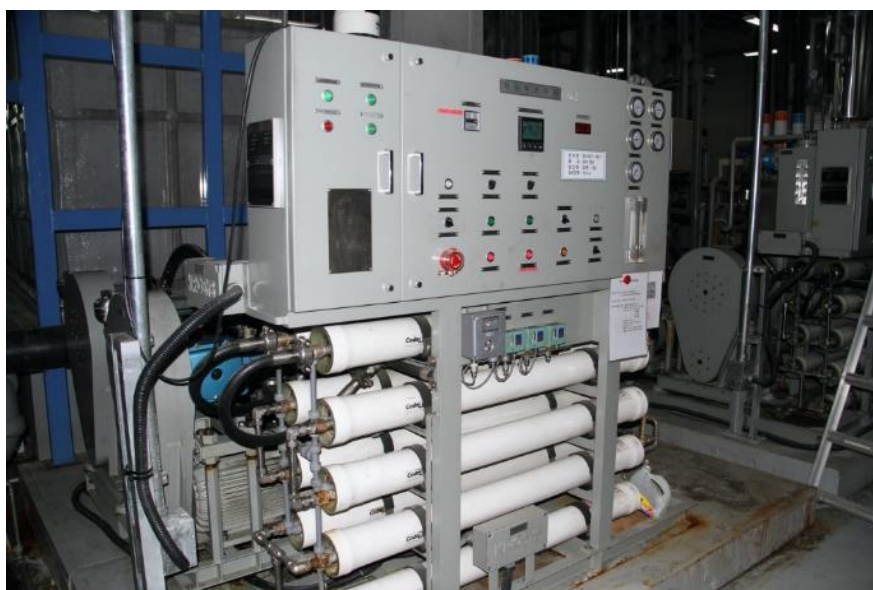
The services building includes a reverse osmosis desalination system for the station, which is capable of producing 20 tons per day. The intake for saltwater was observed close to the pier. The team was advised that brine from the reverse osmosis process is discharged to sea close to the pier, as is treated wastewater. Storage tanks for fresh water, as well as for firefighting were observed. A snow melter was also observed. Water production systems were in very good order.

Photo: Reverse osmosis desalination equipment

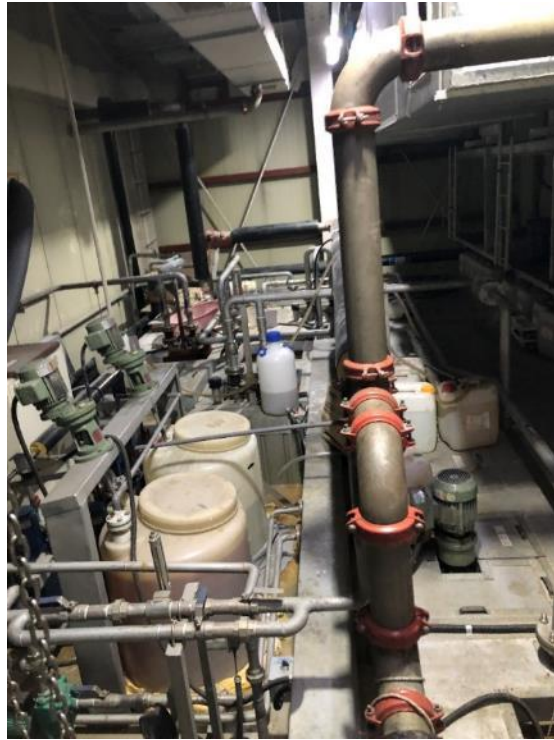
The inspection team observed the wastewater treatment plant in operation in the services building, and it appeared to be maintained in very good order. The system involves 9 stages, and can treat 20 tons per day. Treated wastewater was drawn from the end stage of the system and shown to the team, and it was clear in appearance and odour free. This is discharged to the sea.

Photo: Wastewater treatment plant

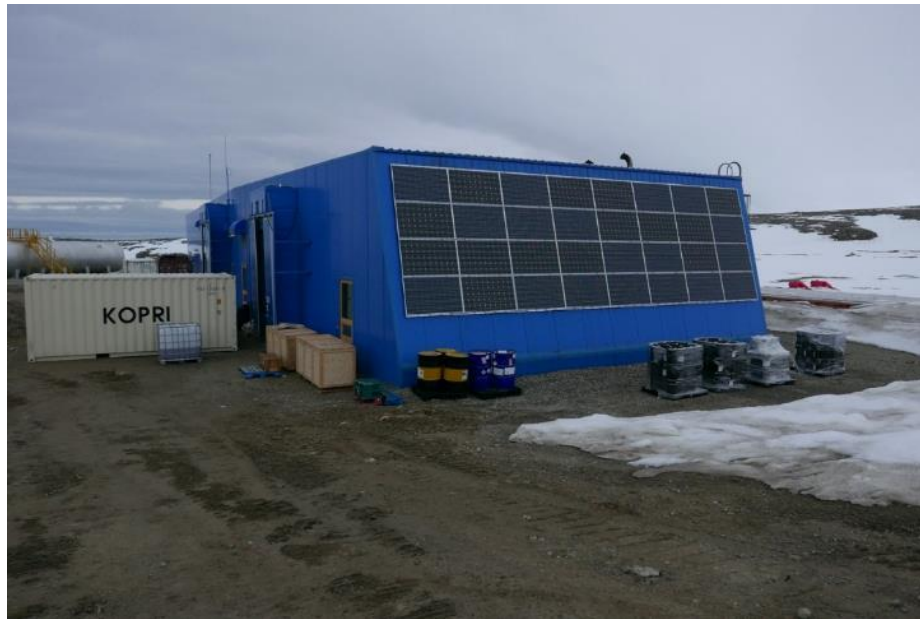
The inspection team toured energy generation and management systems in the services building. Three 275kw generator sets were in operation, and appeared to be in very good condition. There were no signs of any fuel spills or seepages. The inspection team observed a large solar panel installation on the northern side of the services building, and two inverters inside. Station personnel advised that the installed solar capacity was 45kWh. Three wind generator towers were seen, with integrated braces (rather than guy wires), each with multiple vertical turbines. The station leader informed the inspection team that around 25% of the station's energy was provided by solar power. The inspection team was advised that wind energy production had been less than anticipated due to low wind speeds and intermittency. Kitchen cookers were operated with bottled gas.

Photo: Solar array on services building

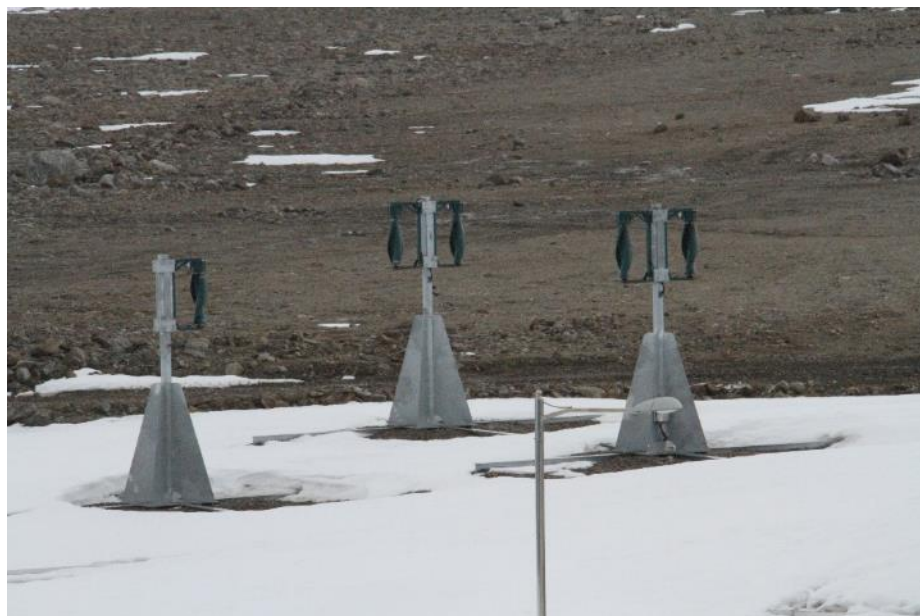
Photo: Vertical axis wind turbines

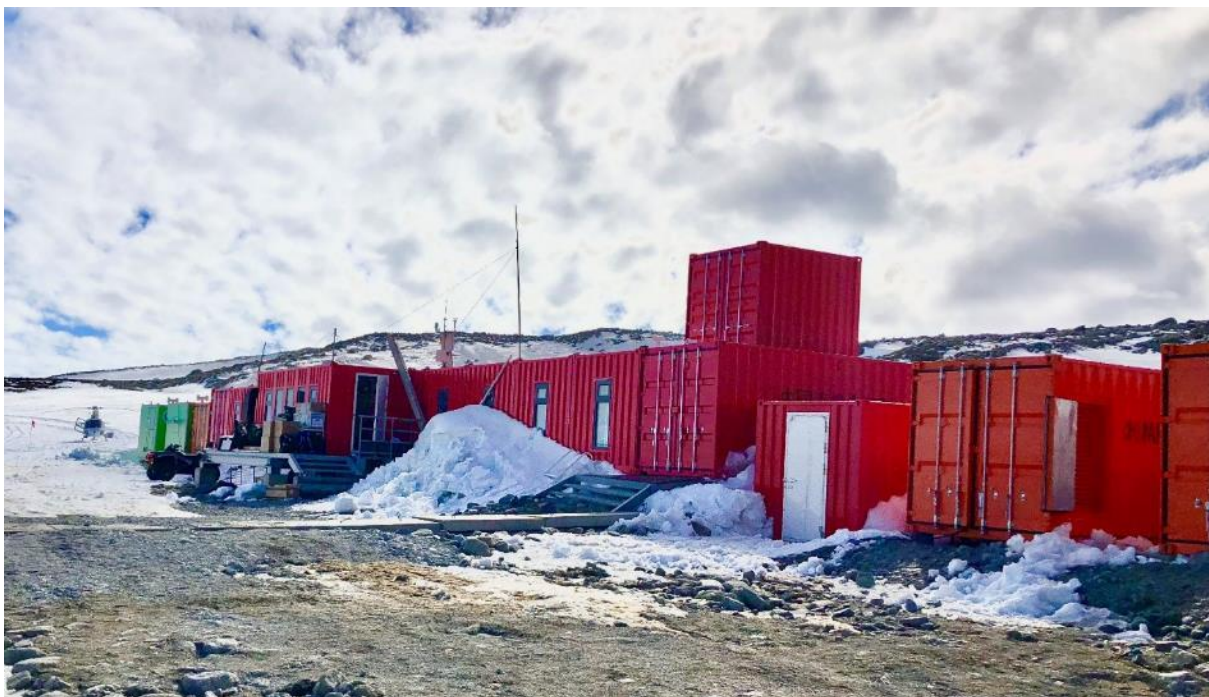
The facility was constructed over a period of approximately three weeks in 2017-2018. It consists of a main building, with modular, containerised design, and associated containers with services including power generation, water production, kitchen, toilet and waste, fuel, and storage. A number of systems and buildings are not yet complete or commissioned. The buildings are new and in good condition, as are the service containers. The main building sits above a levelled gravel road which runs down to a rock and ice platform used as a wharf.

Photo: Main building, and containers housing power generators

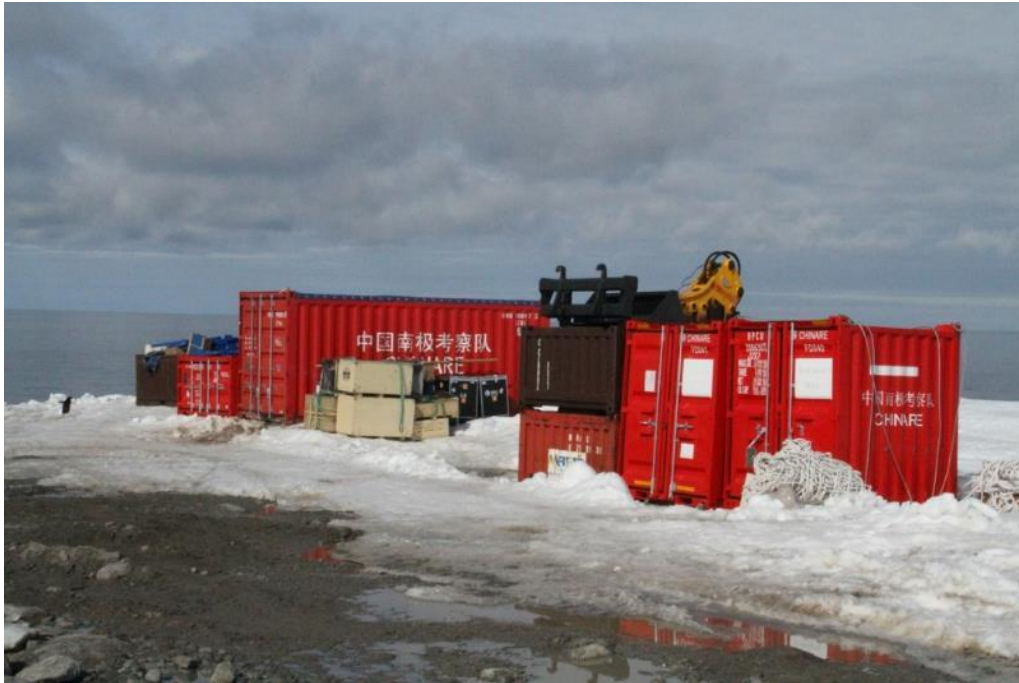
The team inspected the main building, with accommodation, offices, and a mess and kitchen (the kitchen was not yet in operation). Containers with generators; fuel; toilet facilities; water treatment (reverse osmosis) equipment; and a containerised temporary kitchen were also examined. Storage containers with construction equipment, wastes, and other general materials were noted.

Photo: Storage containers opposite main building

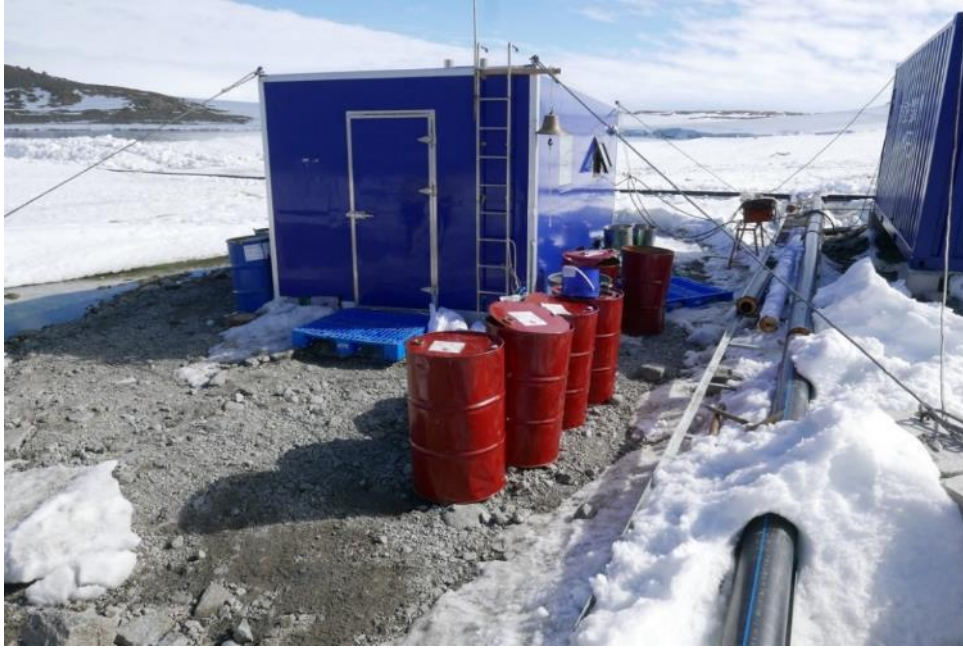
The inspection team observed a container in which general waste was well secured. The collection of food waste in 210 litre drums adjacent to the temporary kitchen facility was also seen. The team was advised that all waste is returned to China via ship.

Photo: Temporary kitchen with kitchen waste drums

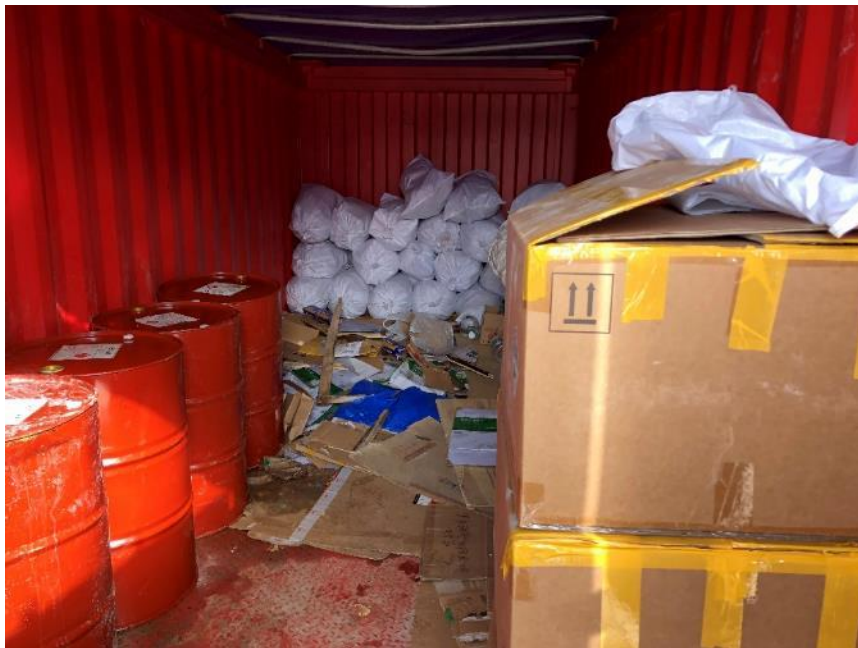
Photo: Waste storage container

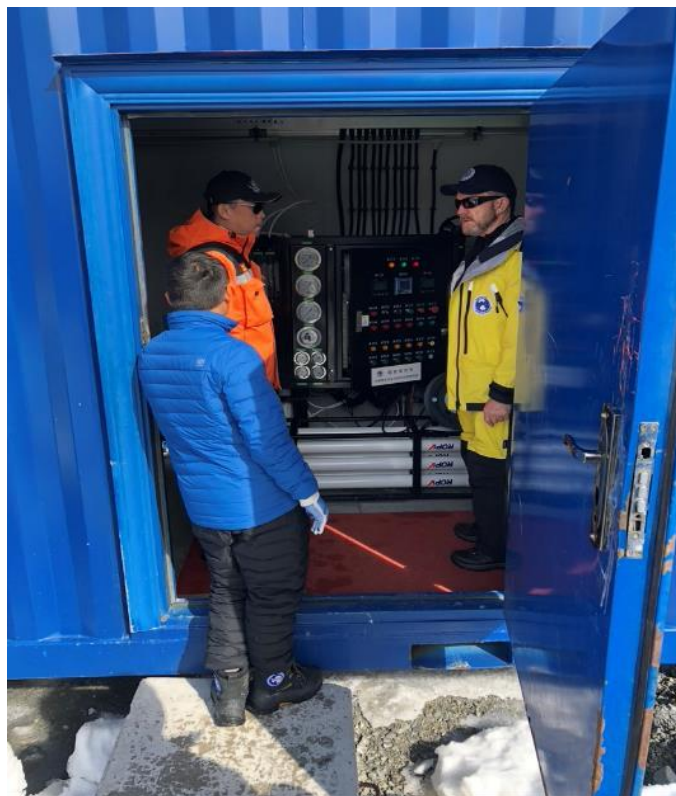
A separate water treatment container for a reverse osmosis system is in place, for fresh water production. Water lines run from the shore to this container, and then on through a culvert under the road area to the area of the main building. A reverse osmosis system is in the process of being installed and tested. In the interim the station is supplied with bottled water.

Photo: Reverse osmosis system

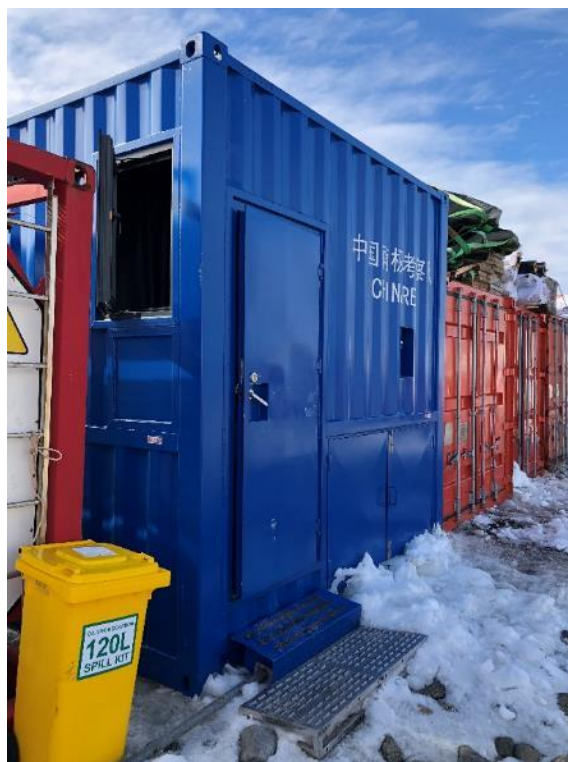
A containerised toilet facility provided tank storage underneath a raised toilet room, for the collection of human wastes for removal from Antarctica.

Photo: Toilet facility

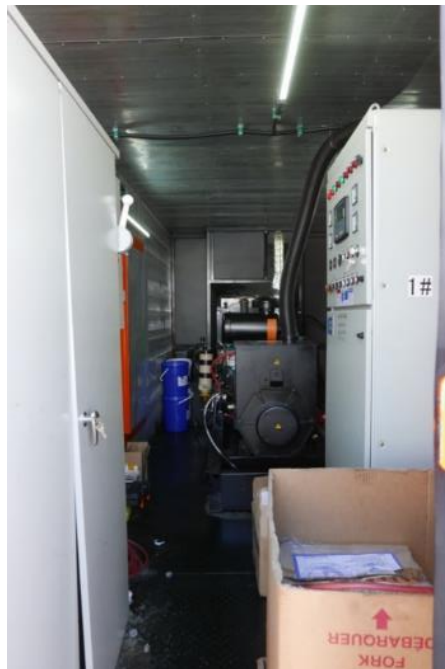
Two diesel generators (one operating while the other acts as an alternate) are located in a container next to the main building.

Photo: Diesel generator

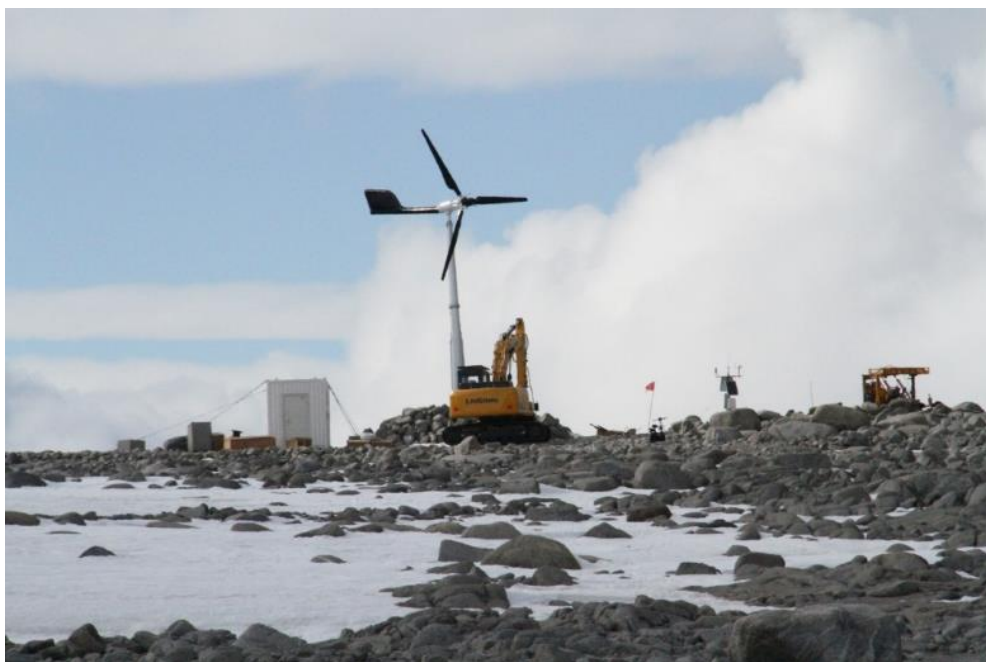
A single wind-turbine is located on the hill behind the station. The inspection team was advised that this was being tested, and has not yet been integrated into the facility's systems. The team observed site works on the hill above the facility, and was advised that work was underway to install solar panels for power generation.

Photo: Wind turbine installation

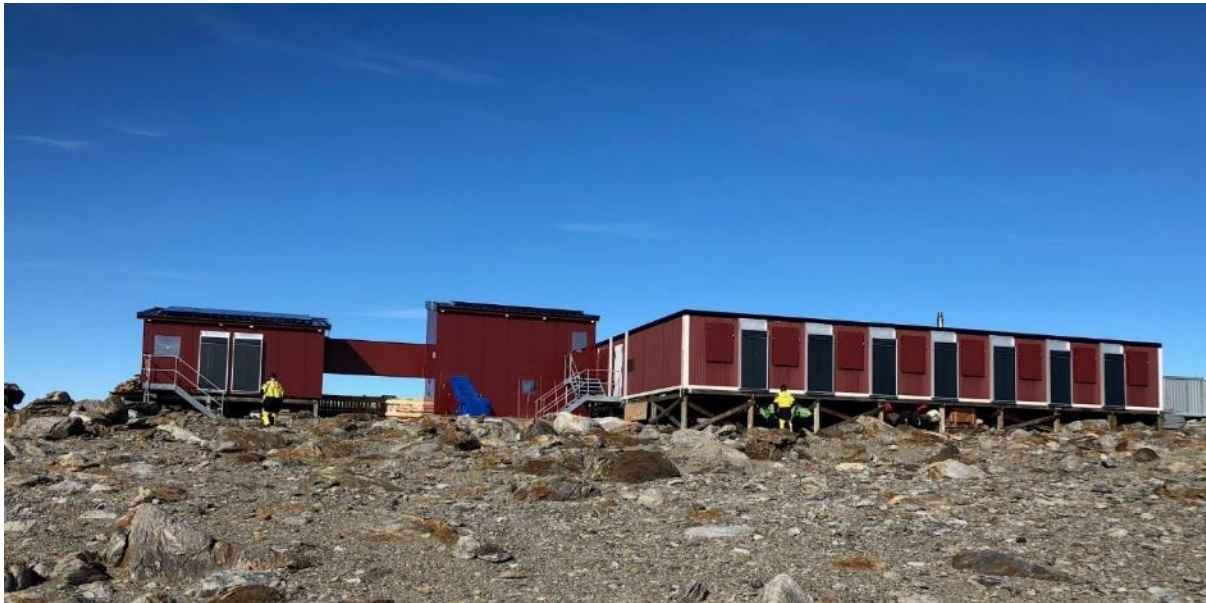
Photo: Gondwana Station main building with 2016 extensions and modernisation

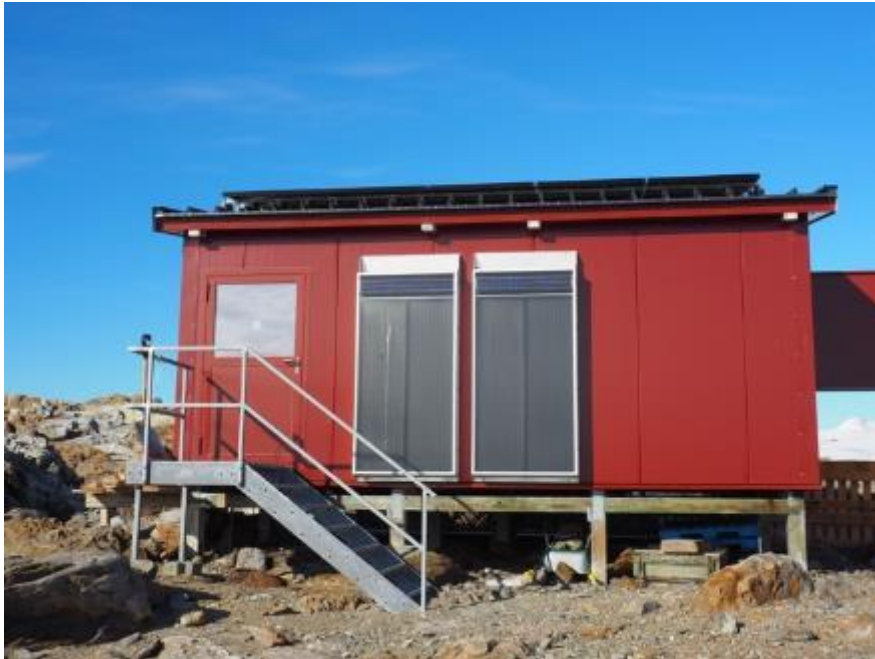
Following the 2016 modernisation, a new services and ablutions building adjoins the main building. A nearby separate power generation and energy distribution building has replaced a previous building, on the same site. The main building has been renovated and painted, and a small deck has been added. A small plywood sauna building has been constructed close to the main building, overlooking Gerlache Inlet.

Photo: Power and energy management building

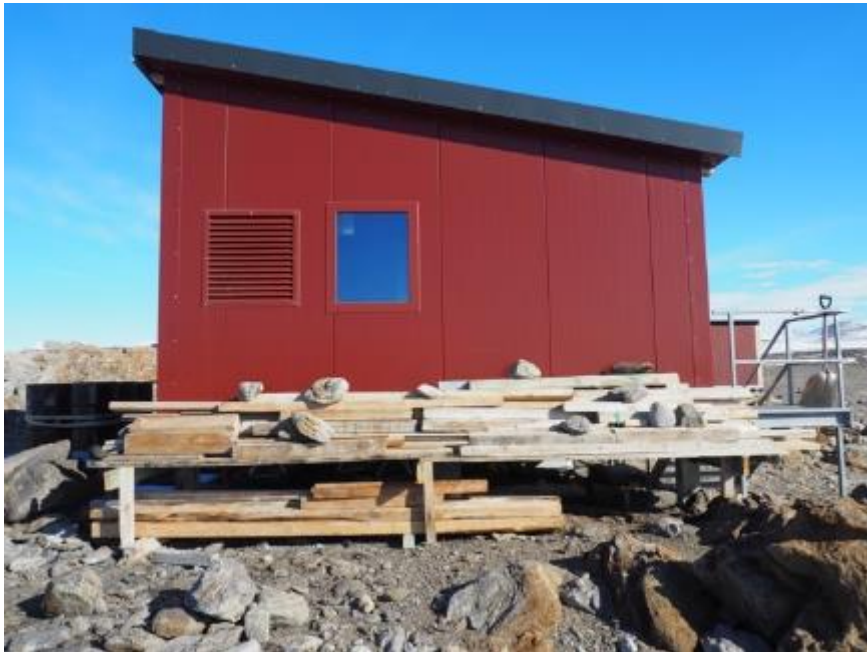
The surrounding environment was free from any debris, loose materials, or signs of contamination or spills.

Photo: Stored materials secured with rocks

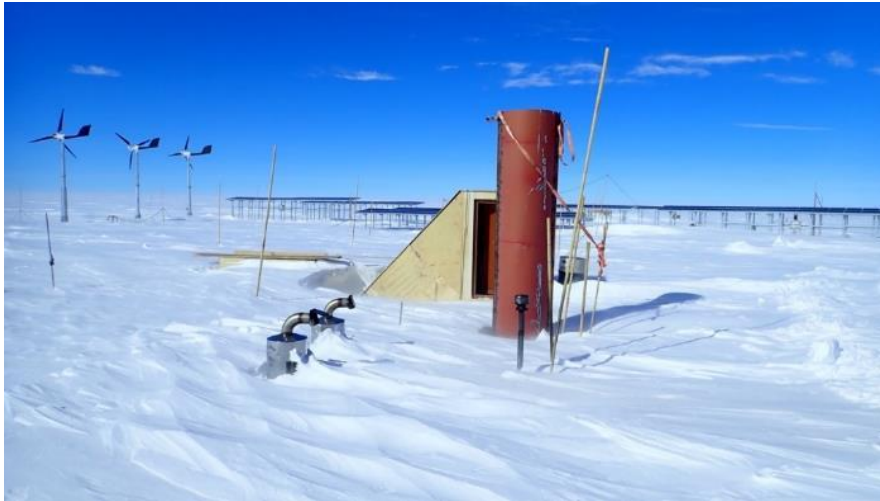
Photo: Entry to undersnow facility, with generator exhausts and air intake

In addition to the renewable power sources, two diesel generators are located in the undersnow building. The inspection team noted the importance of careful management of risks associated with exhaust gases from generators, particularly in an enclosed and below ground-level space. The station team advised that a carbon monoxide alarm system is planned for installation, and that risks would be further reduced through the primary reliance on renewable energy. Back-up generators are located at the mobile site as part of the traverse train.

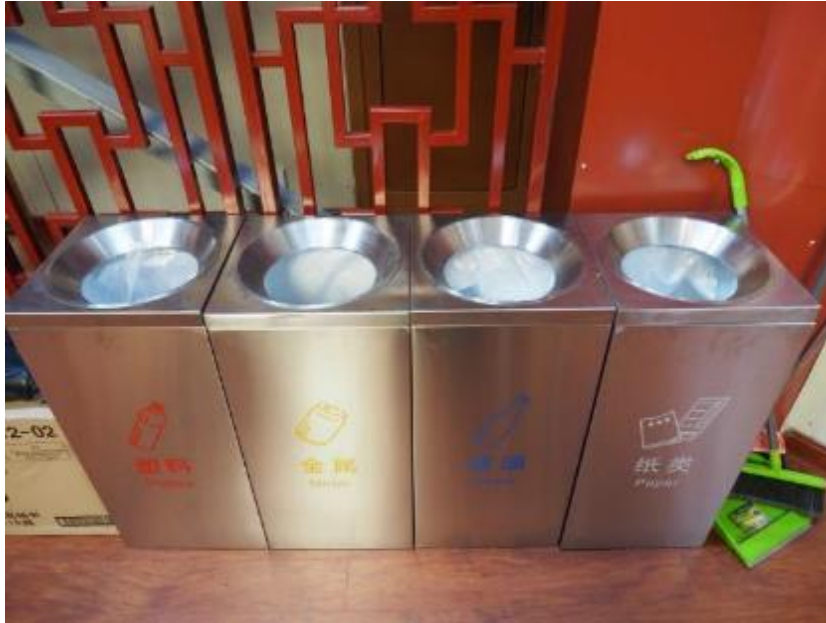
All wastes are removed from the site via traverse to Zhongshan station. The inspection team observed waste separation and recycling stations, including battery receptacles. Food and kitchen waste was contained in bags and stored for return Zhongshan for treatment and return to China. The station leader advised that excess building materials from the construction phases are being returned progressively to Zhongshan Station by traverse.

Photo: Recycling station

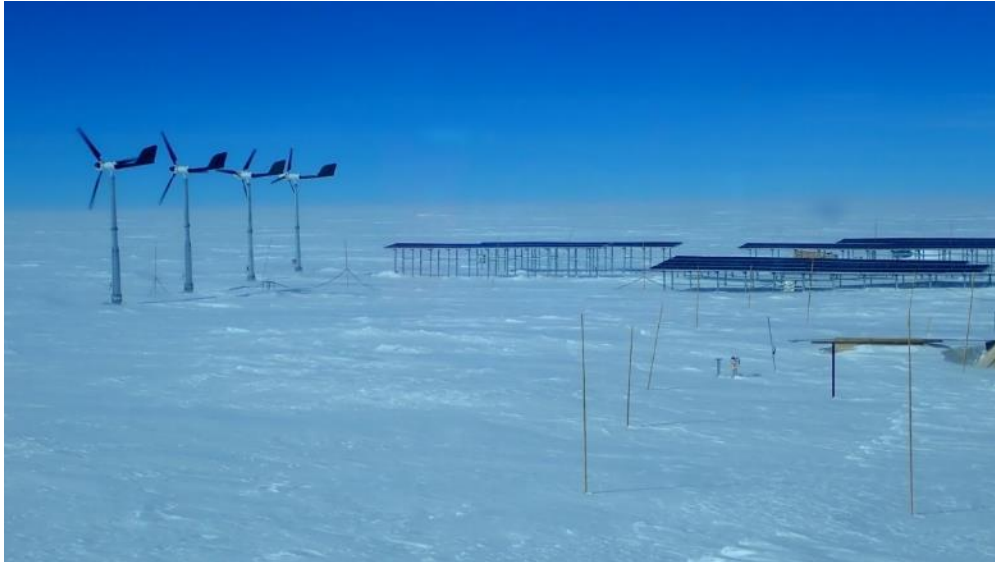
The station requires approximately 36kW when occupied. Four wind turbines (of 5kW each) with UV protected carbon fibre blades are in place and operating, although associated electrical systems are yet to be commissioned to bring this capacity online. These turbines were designed following a testing phases using two smaller turbines which remain in place.

Eight rows of solar panels (total of 40kW) are also installed. The solar panels utilise a double sided design which allows solar energy to be collected from direct sunlight as well as reflection from the snow. As part of the renewable energy system, 110kW of battery storage is available.

Photo: Wind turbines and solar panel array

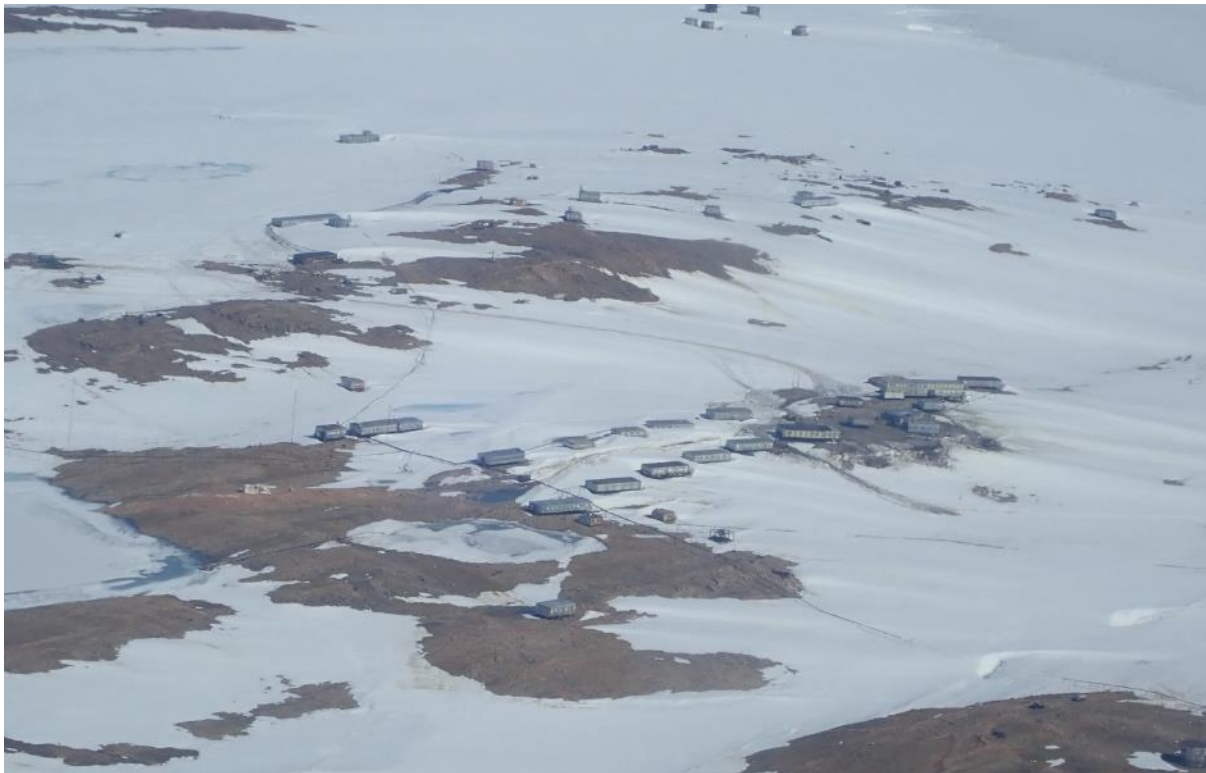
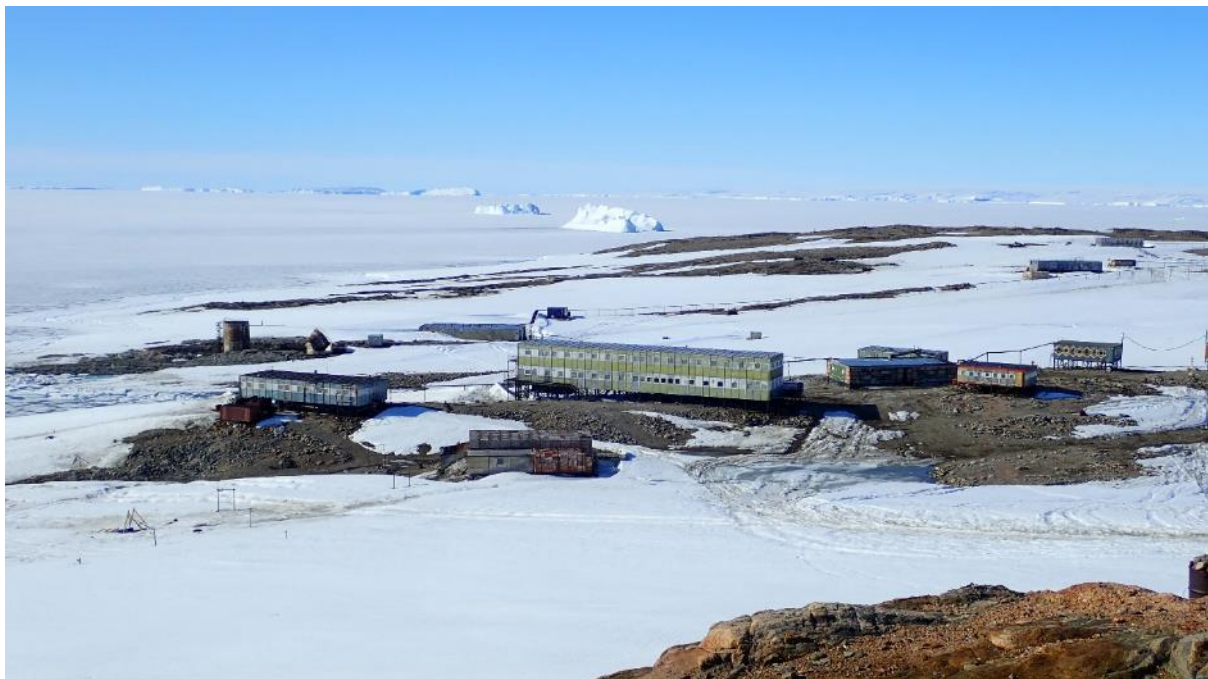
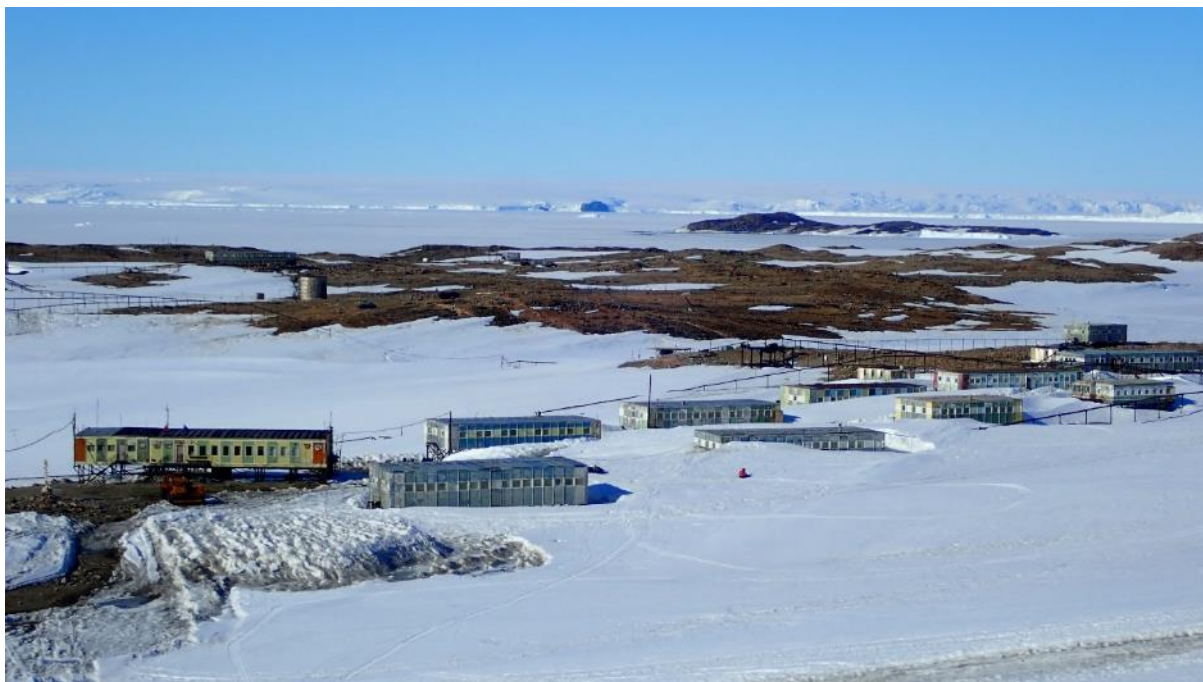
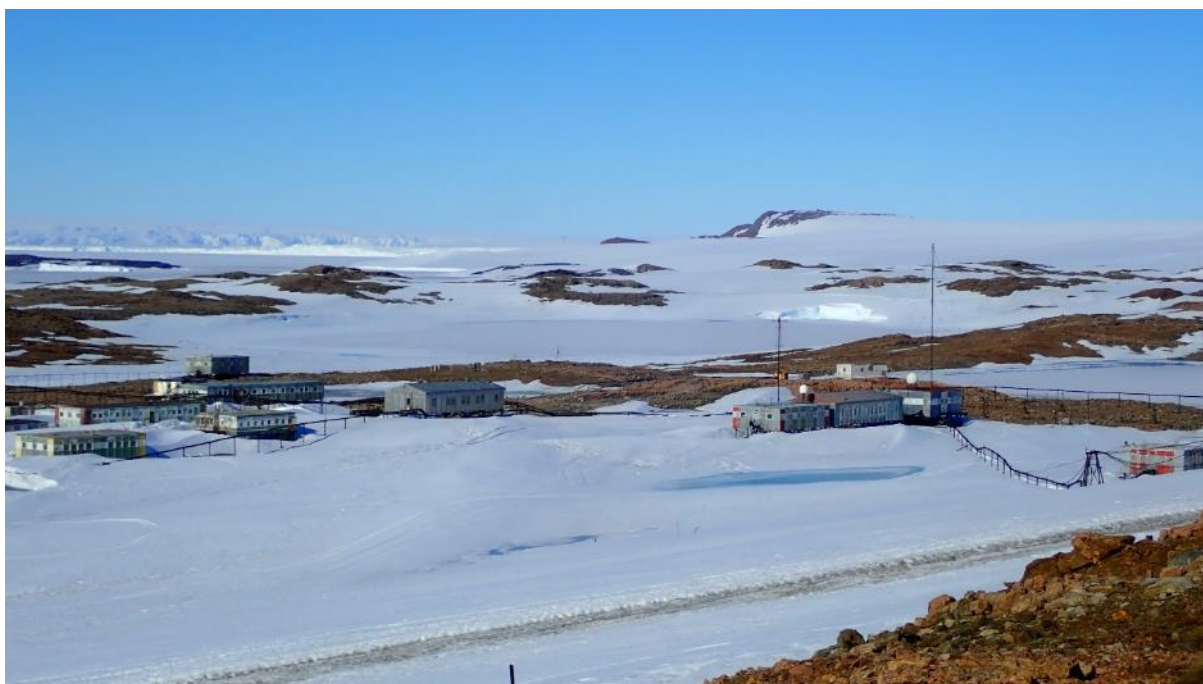
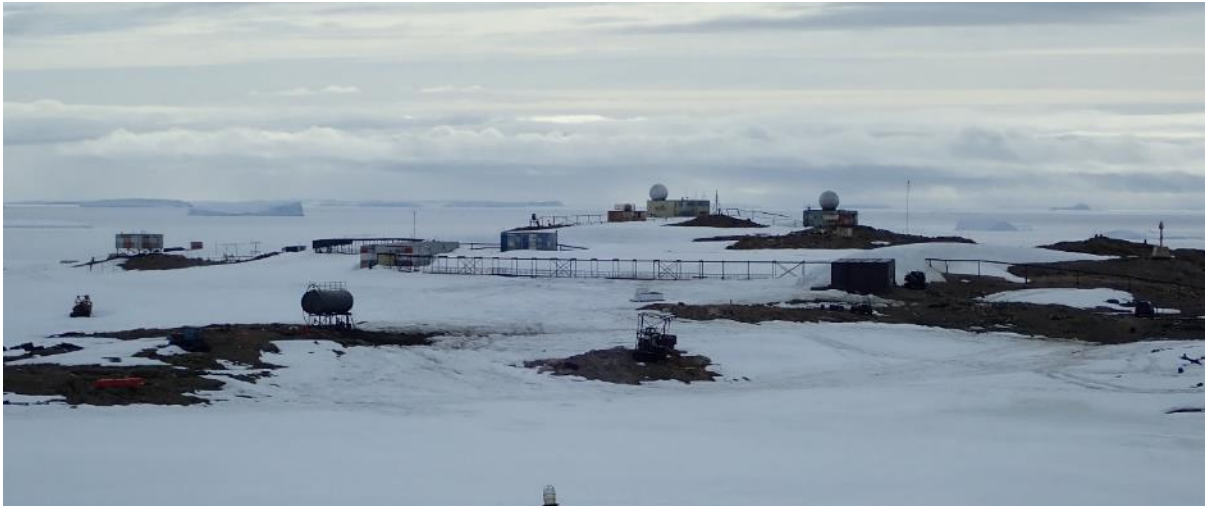
Photo: Part of Molodezhnaya Station area

Molodezhnaya Station is an extensive complex of buildings, infrastructure, scientific installations, storages and associated materials. Much of this is unused and in a poor state of repair, and wastes are evident.

The majority of the Molodezhnaya station infrastructure is unused and much is damaged by the elements. Deterioration of buildings, equipment, and stored materials is ongoing, with large quantities of degraded or loose materials observed to have been released to the environment. The further release and distribution by wind and water of such materials is, in the view of the inspection team, likely to continue.

In the view of the inspection team, it will be a very substantial challenge to clean up wastes, contaminants, equipment and infrastructure, and/or repair and re-use suitable buildings and equipment. Removal, remediation, repair or re-use of the station to reduce the risk of further environmental impacts would represent a very considerable logistic and environmental management challenge, but should be regarded as a priority.

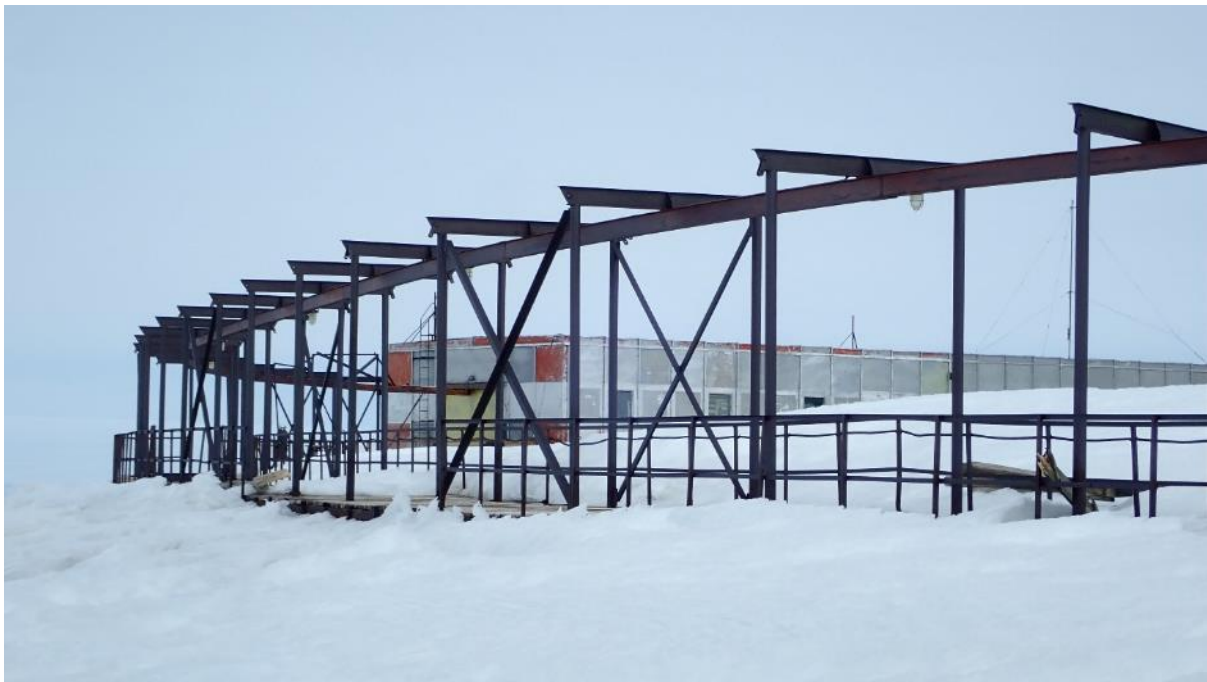
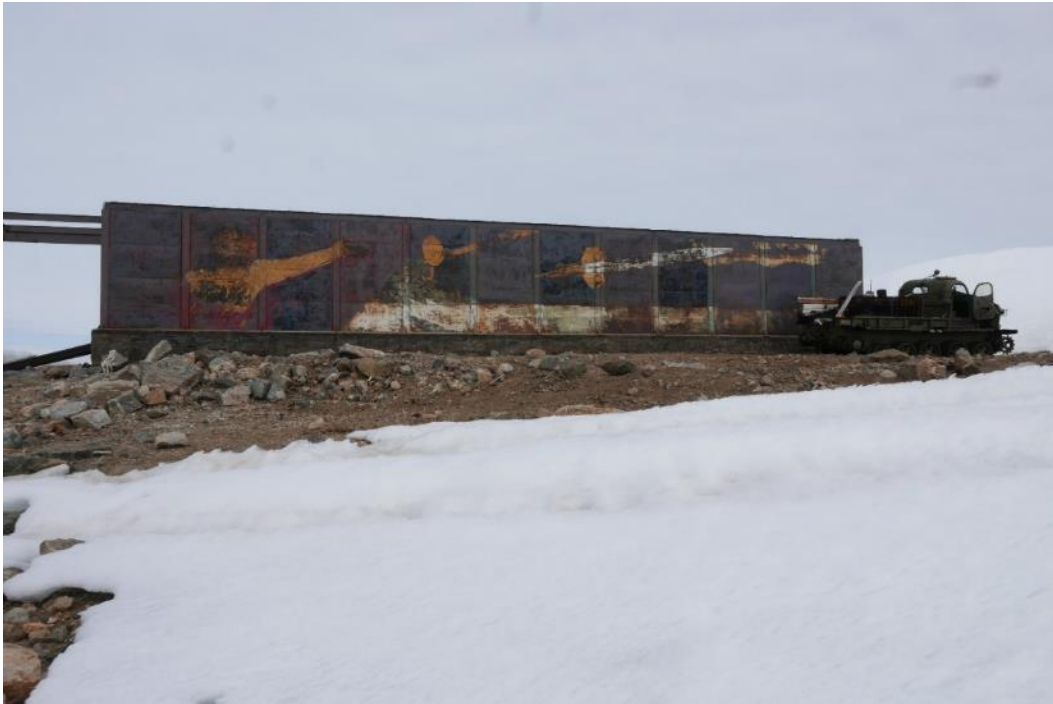
Photo: Research rocket complex - assembly gantry and building

Photo: Research rocket complex - assembly building
