Australian Antarctic Treaty Inspections January/February 2020

Report of Inspections under Article VII of the Antarctic Treaty and
Article 14 of the Protocol on Environment Protection to the Antarctic
Treaty

Jang Bogo Station (Republic of Korea)

Molodezhnaya Station (Russian Federation)

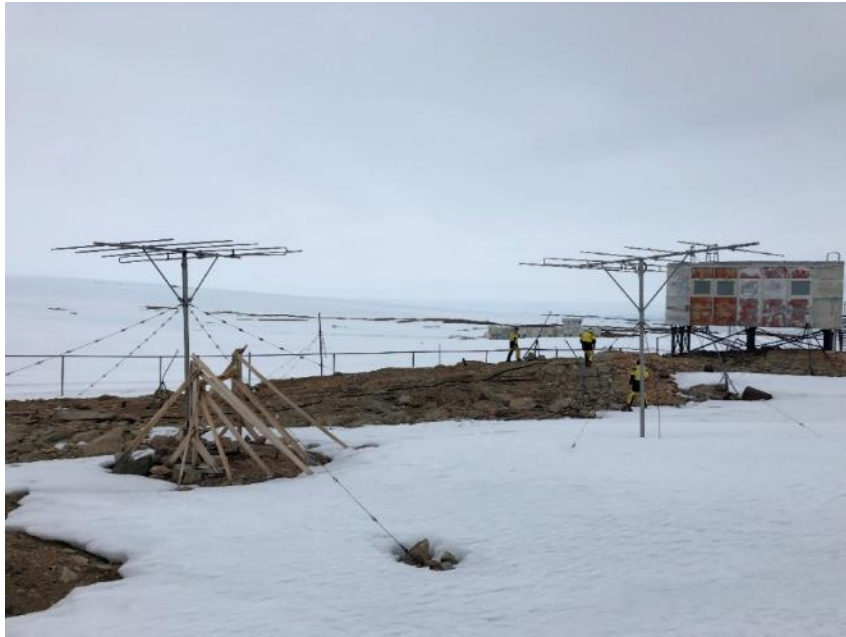
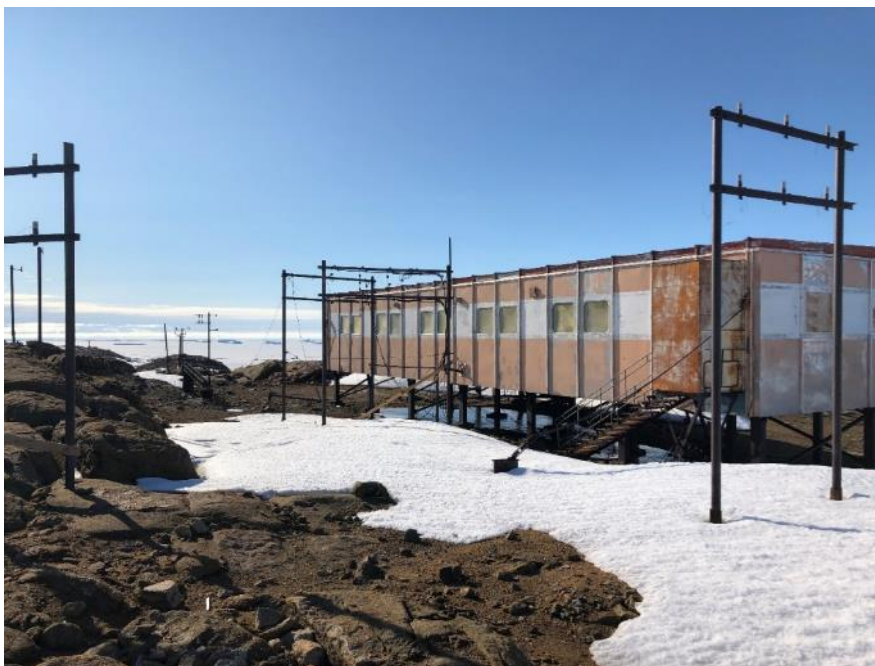
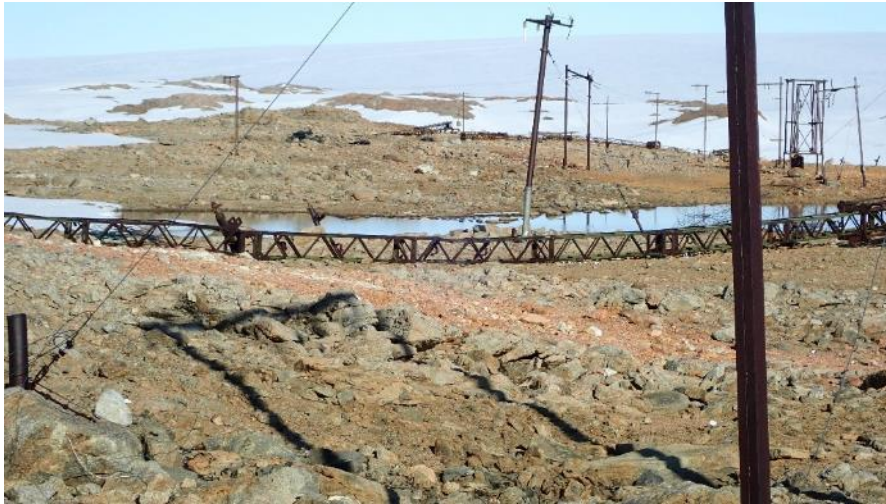
Extensive external infrastructure was also observed, much in poor repair, including a network of elevated site services on steel poles, cables and pipework, a water pipeline between a large lake and the sea, a walkway/gantry associated with research rocket assembly, and many large antennas and arrays.

Photo: Antenna array

Photo: Remains of antenna array

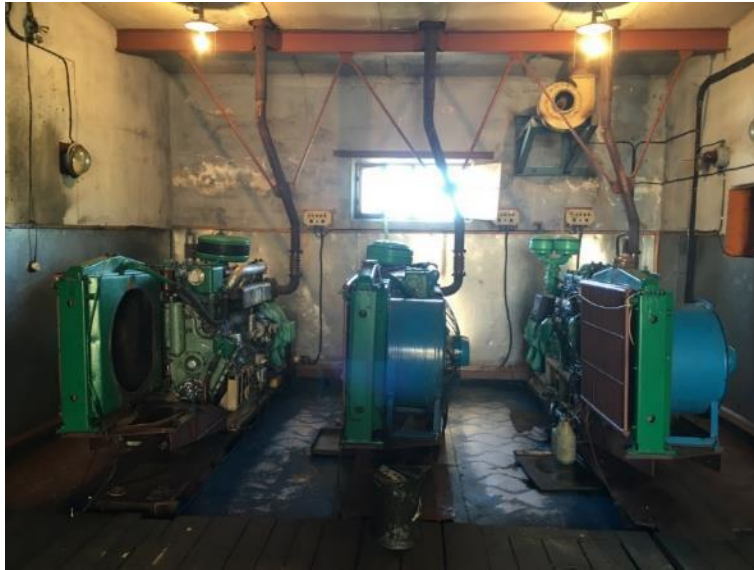
A power house with three generator sets and workshops and storages was inspected. Fuel is transported from a bulk storage, in 200l drums on a sled. The powerhouse, generators and fuel system were observed to be good condition.

Photo: Seasonal operation powerhouse

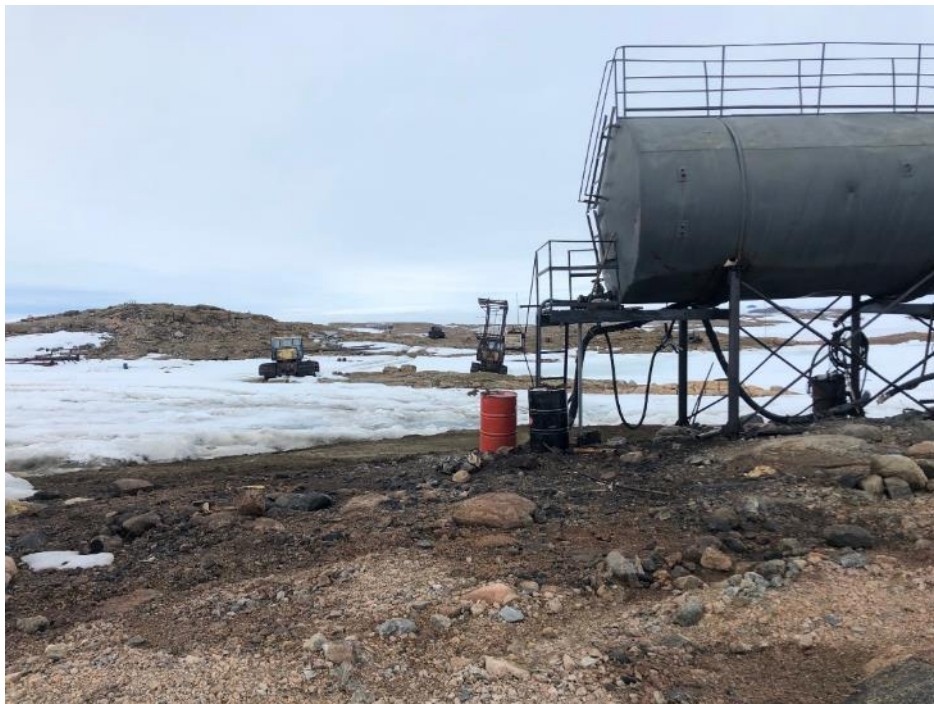
Fuel for the seasonal operation is transported by helicopter in an aviation bulk fuel tank and pumped into an elevated storage tank. Drums for transport to the power house and vehicles are fuelled from this tank. The storage tank, hoses, nozzles and pipework were observed to be in a relatively poor condition, and there was no secondary containment. There appeared to be extensive fuel contamination in the sediments and on rock surrounding the storage. In the view of the inspection team an upgraded bulk fuel storage and associated pipework would be beneficial, as would attention to fuel handling systems.

Photo: Seasonal operation fuel storage

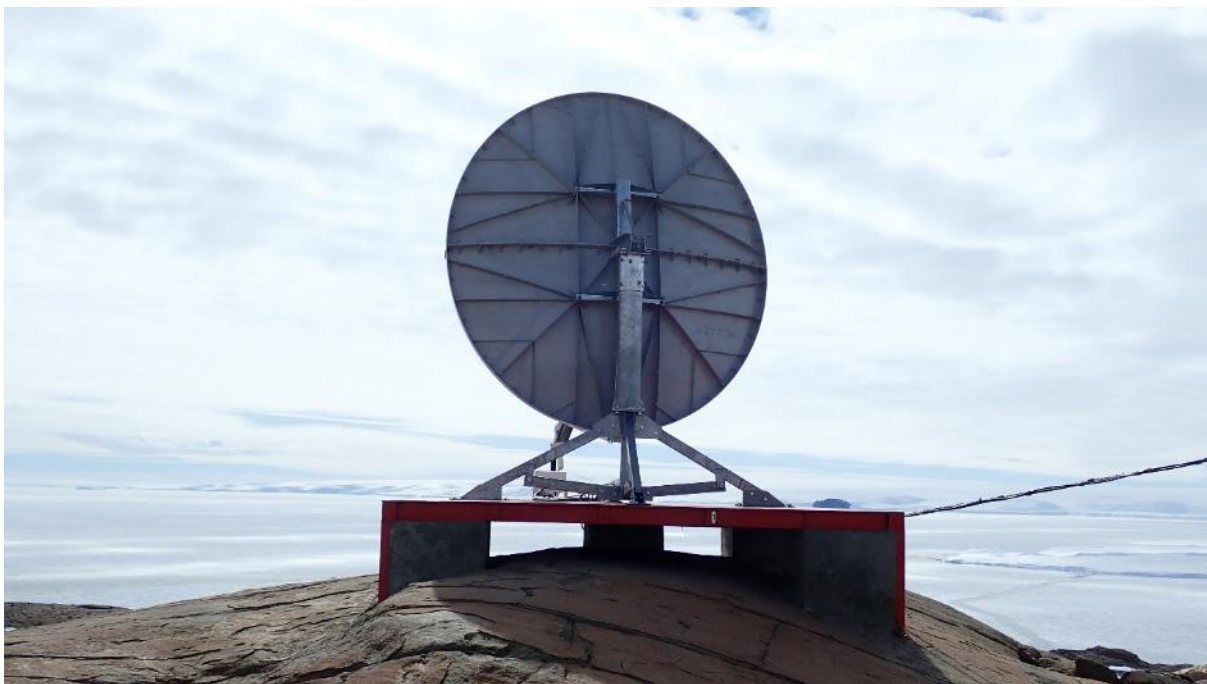
The inspection team were shown the station operations, communications and weather information facilities in the control and communications module. Satellite (BGAN, FLEET, Iridium and Inmarsat C) and radio (HF and VHF) communications are available. A VSAT installation is underway, to provide data services.

Photo: VSAT data satellite installation in progress

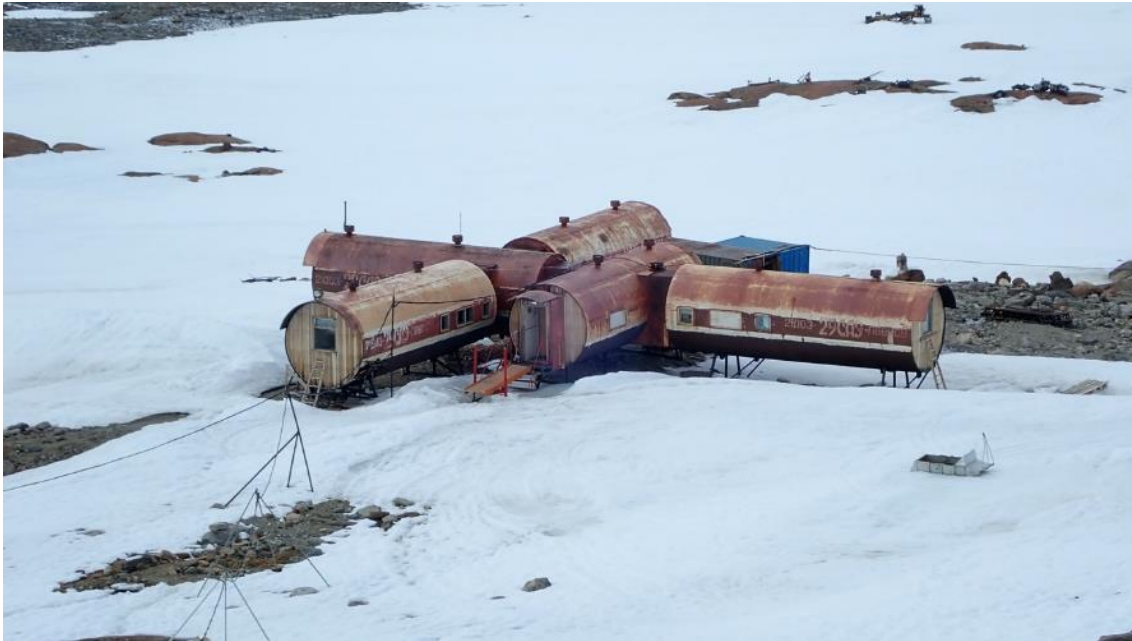
A former residential building (modular cylindrical construction) has been renovated and now contains living, kitchen / mess, ablutions, residential premises, offices, and medical facilities. Another building is partially repaired, and currently houses a biological laboratory space, and will also be used for warehousing and a sports recreation space. Other buildings are used for equipment storage. A small building has been repaired and is used as a living space.

Photo: Re-purposed modular building - accommodation, kitchen and mess facilities

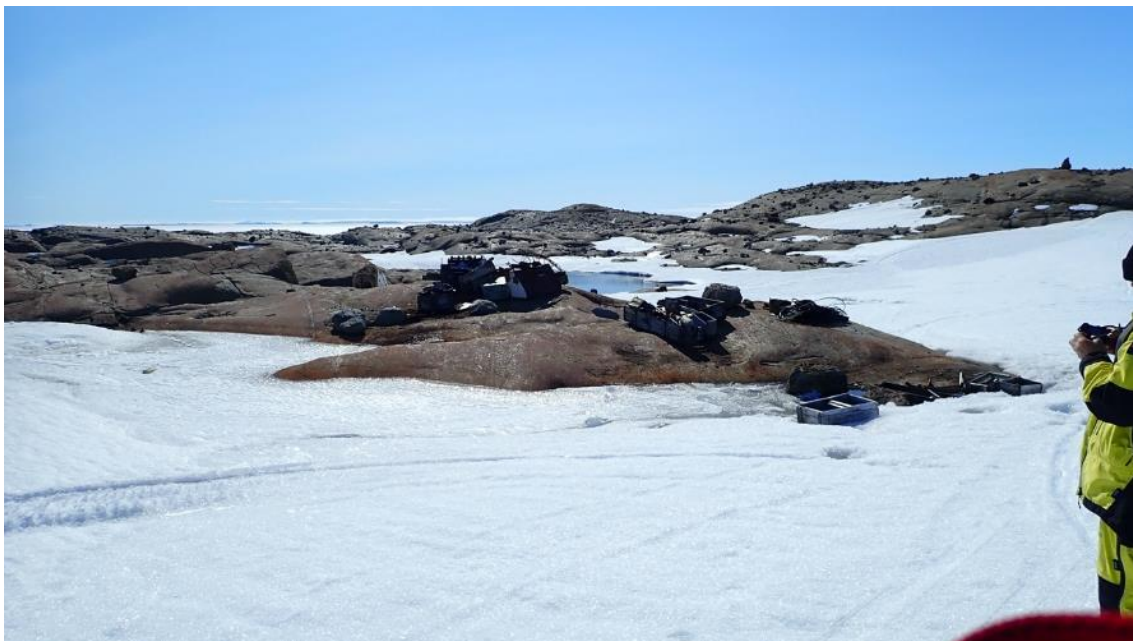
The inspection team observed that considerable material associated with the Soviet Union's former year round airfield base remains in the station area and surrounds. This includes buildings, vehicles, generators and heavy equipment, cables, drums, and other waste. A significant proportion of this material appeared to have deteriorated or was otherwise unusable. The inspection team was informed that Belarus, as a former partial user of sites as part of the Soviet Antarctic expeditions, takes part in joint Belarussian-Russian clean-up work. The Belarussian Antarctic Expedition each season collects 7-10 tons of metal, solid wastes, and other equipment from the station area and surrounds, for removal via ship, in cooperation with the Russian Antarctic Expedition. The inspection team observed materials that have been collected in a helicopter sling-load container ready for removal, and additional material consolidated on elevated rock outcrops prepared for lifting.

Photo: Materials moved to rock outcrops in preparation for removal to ship

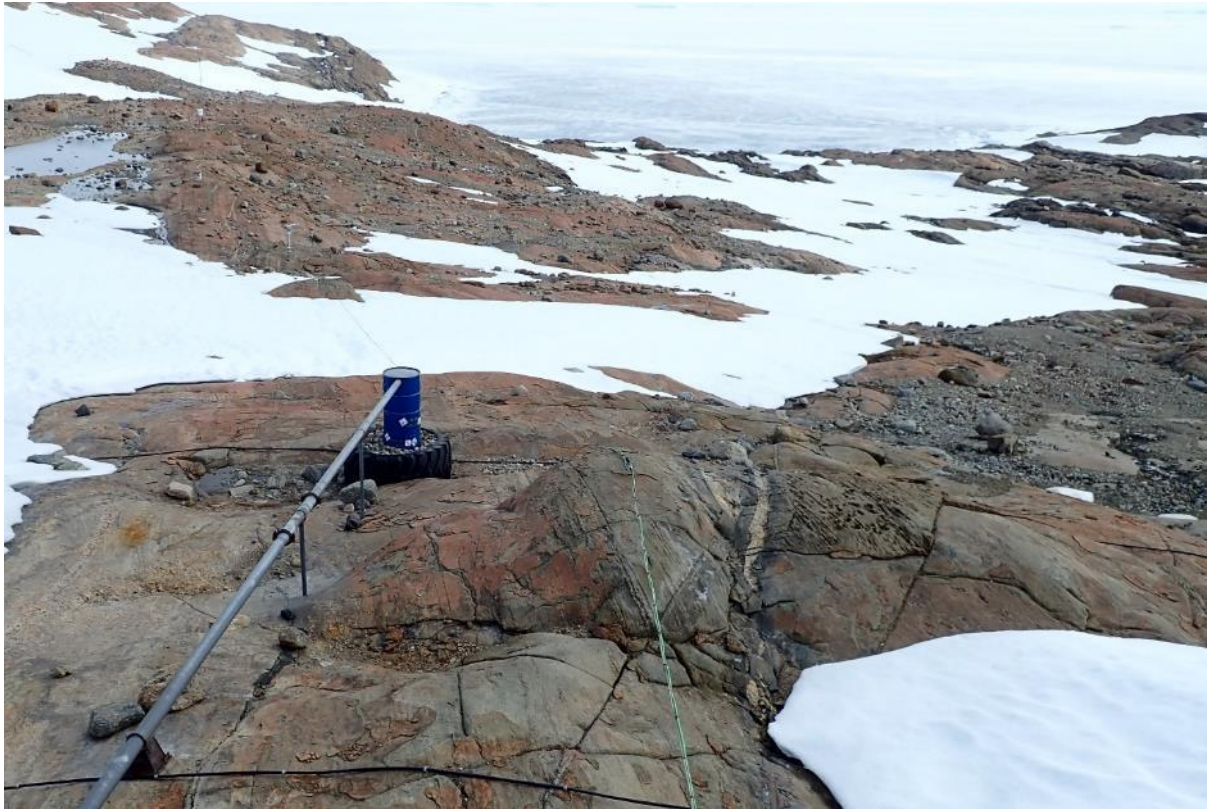
The inspection team notes that the final CEE for the station indicates that a wastewater treatment facility, for black and grey wastewater is intended, with a discharge pipeline directly into the sea.

Photo: Grey water filtration tower

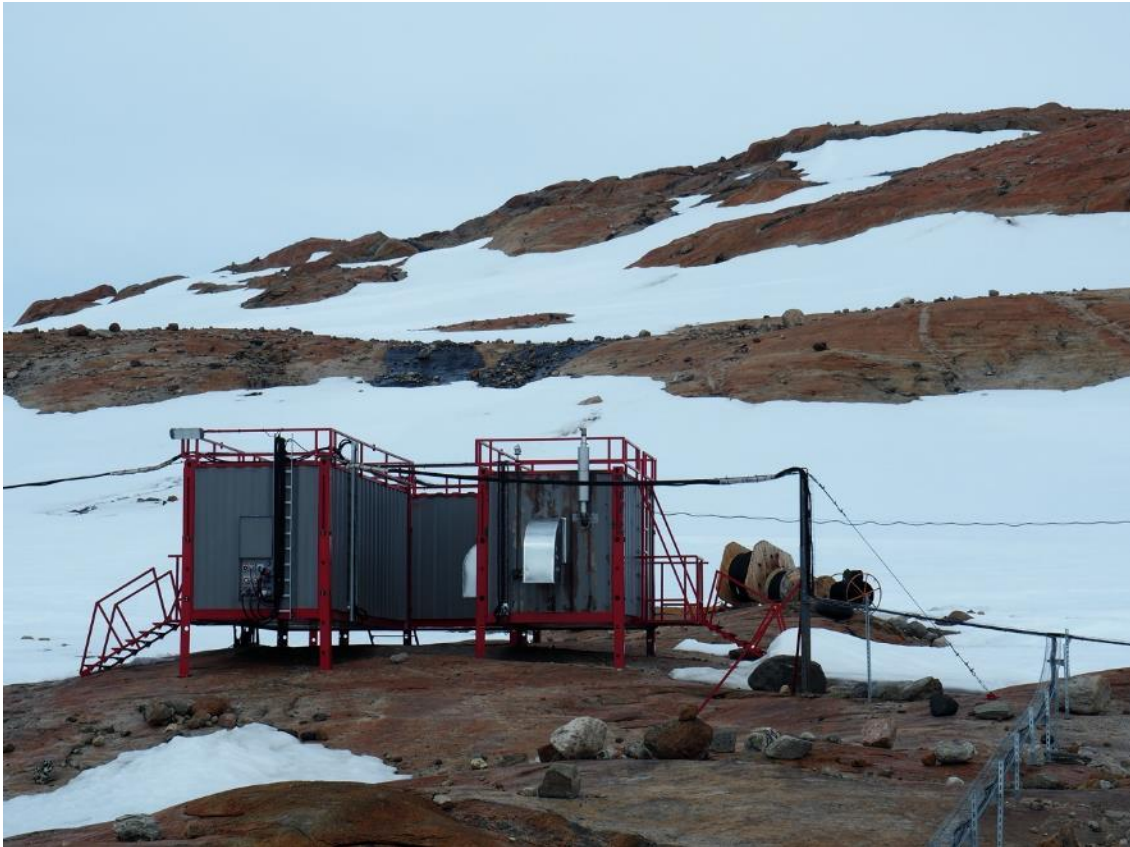
The station uses diesel power generators. Four generator sets of differing capacities are used according to the power consumption at the time. The generator sets were each housed in their own container, and were observed to be well maintained and in good condition. The new station modules included energy efficient lighting and other power management measures. Some photovoltaic panels were installed.

Photo: Containers housing diesel generators

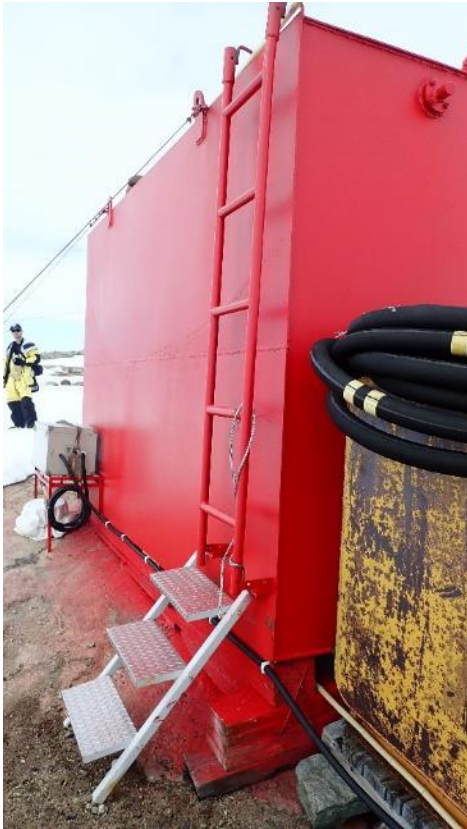
Currently, a single skinned steel-plate tank of 13 m³ is used to store diesel fuel. The tank is placed on a rock surface on timber baulks. No secondary containment was in place. A single welded pipe outlet with a valve at the base of the tank was connected to a pump. A small container with sorbent material was in place under this valve/outlet. Smaller empty tanks were in place beside the main tank, to provide some capacity for moving and storing fuel in the event of a problem with the main tank, although these did not have the capacity to contain the entire tank contents.

Photo: Bulk fuel tank

The inspection team noted that the lack of secondary containment on the main storage, and vulnerable outlet pipework posed some risk of fuel loss. This is partially mitigated by strong fuel management practices, including a simple fuel transfer infrastructure and procedure, absence of fixed pipework, and regular monitoring. Nonetheless, secondary containment of the tank, outlet, pump and attached hoses, and physical barrier protection for those elements, would enhance the fuel storage system, and reduce further the risk of spills escaping to the environment.

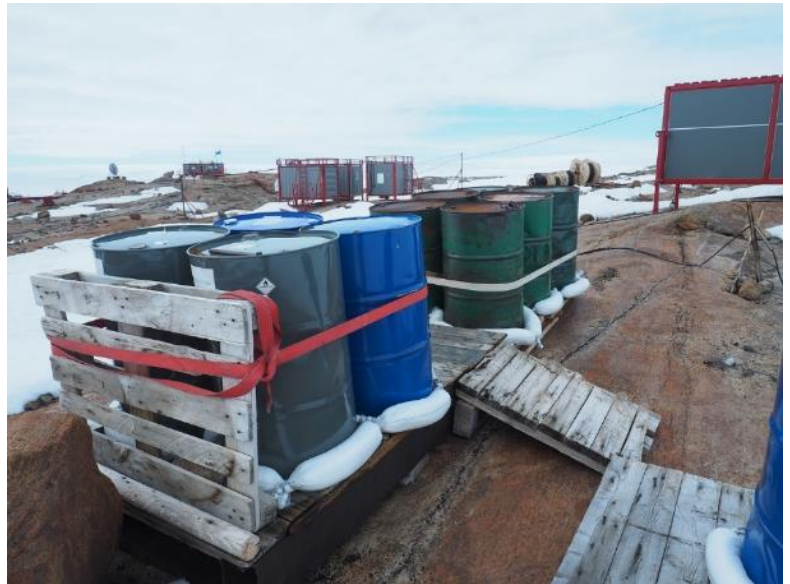
Photo: Fuel drum storage

The inspection team was advised that the tank and stop valves were inspected visually twice daily. For fuel transfers to the generator holding tanks, two appropriately trained people work together, and have communications equipment to coordinate the operation. The head of the expedition noted that fuel management and handling are consistent with COMNAP guidelines. Fuel spill containment and response materials were available and sorbent materials were in place around tanks and generator areas. Small numbers of 200l drums of other fuels were stored in the station area. Sorbent booms were in place at the base of these drums, which appeared suitable for handling small spills.
