Conserving our connections: the 2002-03 Mawson's Huts Expedition

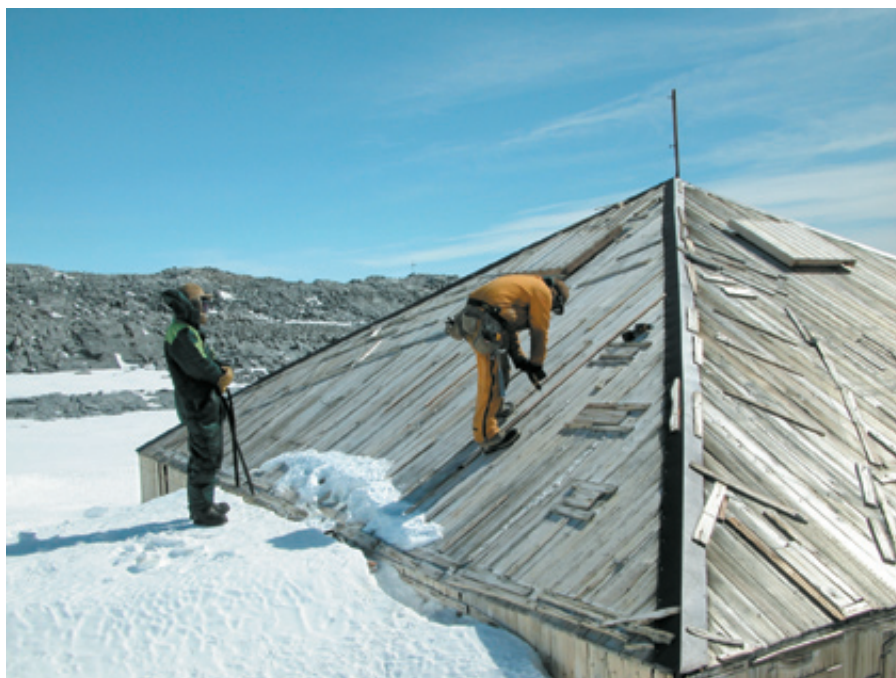
Above right: Fitting battens to gaps in the tongue and groove baltic pine cladding, southern plane of the main hut roof.

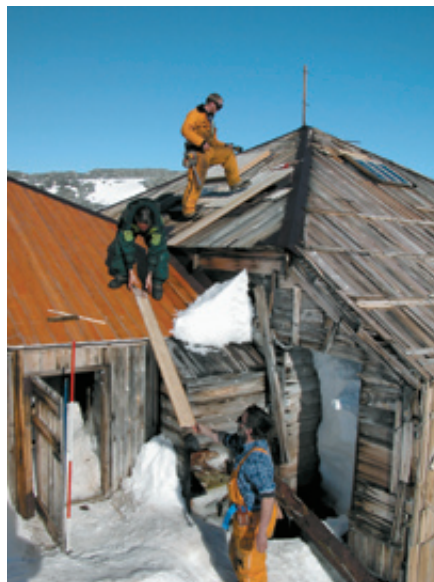
Top to bottom: Expeditioners dig to reveal foundations of the workshop to assess their stability; Roof repairs to the northern plane of the Main Hut; Heritage carpenter Mike Staples and Conservator Linda Clark with environmental monitoring equipment to record temperature and humidity inside the Huts.
